Building damage in Dujiangyan during Wenchuan Earthquake

Abstract: A field damage survey of 1,005 buildings damaged by the Wenchuan Earthquake in Dujiangyan City was carried out and the resulting data was analyzed using the statistical method. It is shown that buildings that were seismically designed achieved the desired seismic fortification target; they sustained less damage than the non-seismically designed buildings. Among the seismically designed buildings investigated, RC frame buildings performed the best in terms of seismic resistance. Masonry buildings with a ground story of RC frame structure were the second best, and masonry buildings performed the worst. Considering building height, multistory buildings sustained more severe damage than high-rise buildings and 2- and 3-story buildings. Compared to residential buildings, public buildings, such as schools and hospitals, suffered more severe damage.

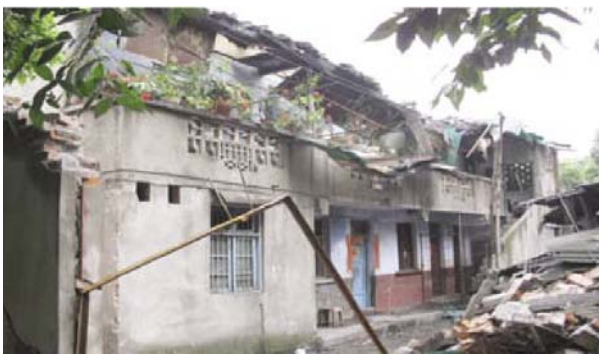
Fig 2 Two-story brick-wood residential building in Hongzhuangjie District (Group A, roof collapsed)

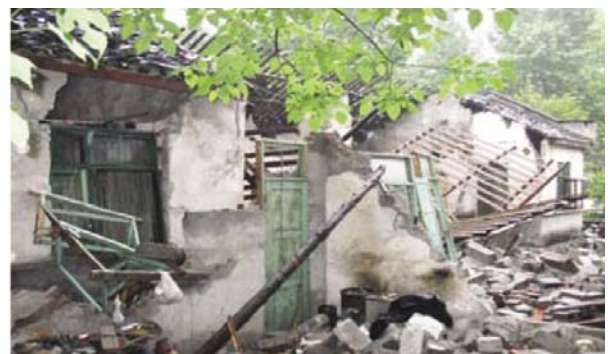
Fig. 4 Brick-wood residential building in Yangcha Village (Group A, collapsed)

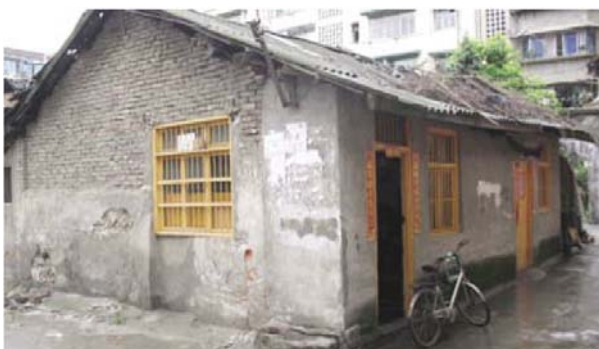
Fig. 3 One-story brick-wood hut (GroupA, moderately damaged)

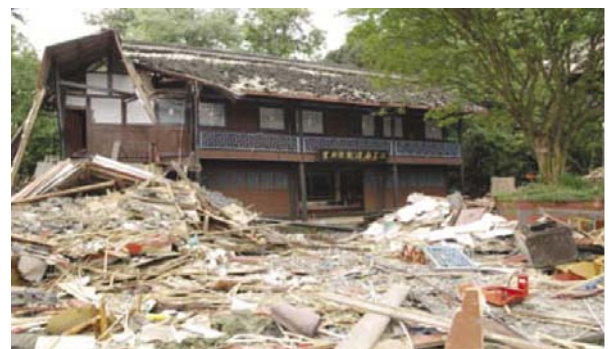
Fig. 5 Timber structure in Erwangmiao scenic spot (Group A, roof damaged, inclined)

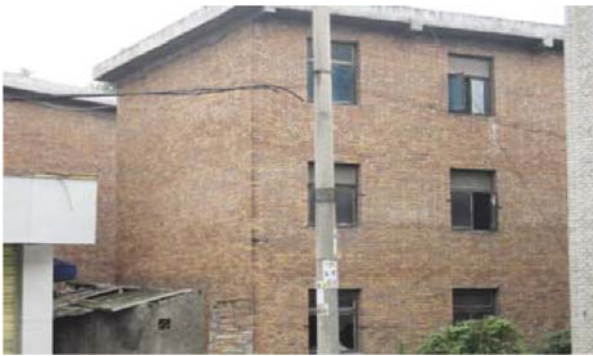
Fig. 6 Masonry building in Kuiguang Street (Group B, moderately damaged)

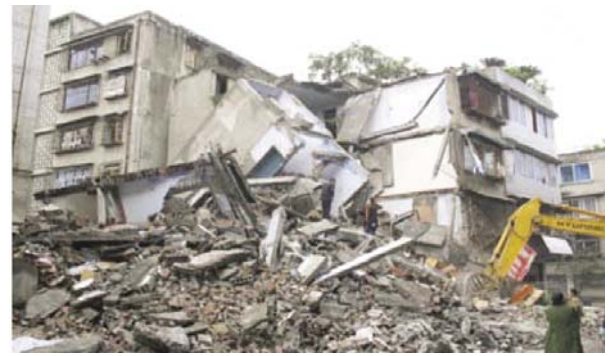
Fig. 10 Masonry residential building in Kuiyuandongjie District (Group B, collapsed)

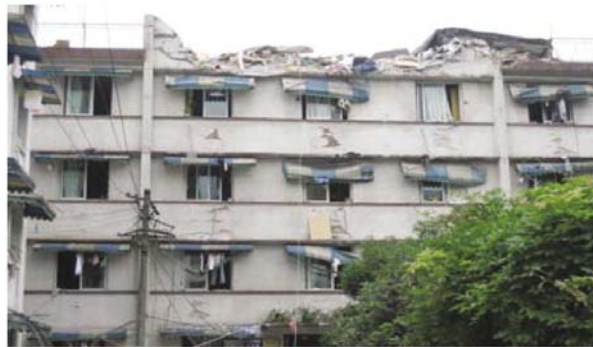
Fig. 7 Masonry structure, students' dormitory of Chengdu University (Group B, top collapsed)

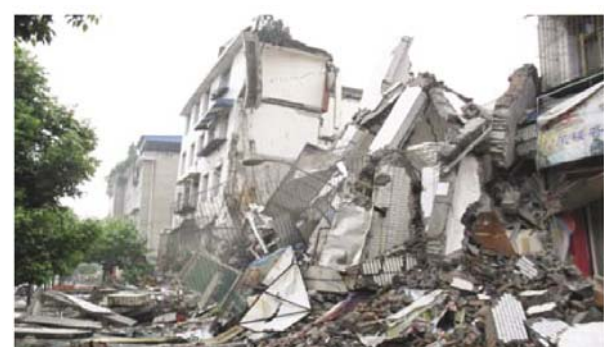
Fig. 9 Masonry structure in Hehuachi District (Group B, collapsed)

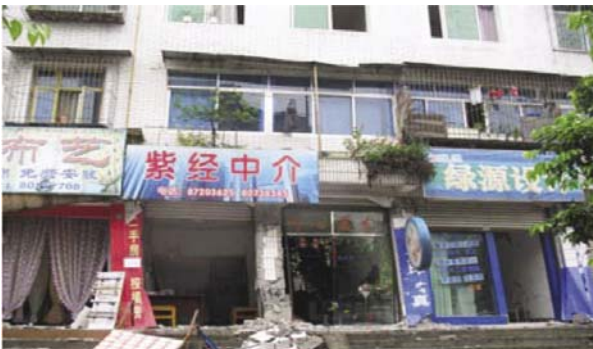
Fig. 8 Masonry building with a ground story of RC frame structure in Hehuachi District (Group B, seriously damaged)

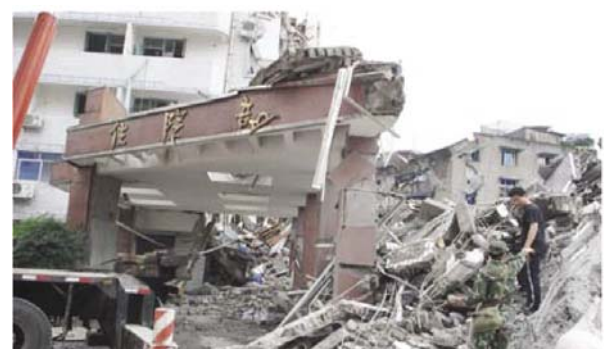
Fig. 11 Inpatient department of Hospital of Traditional Chinese Medicine (Group B, collapsed)

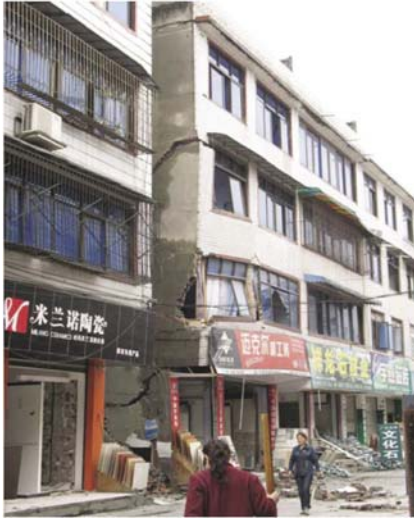
Fig. 12 Masonry building with a ground story of RC frame in Kuiyuanxijie District (Group B, seriously damaged)

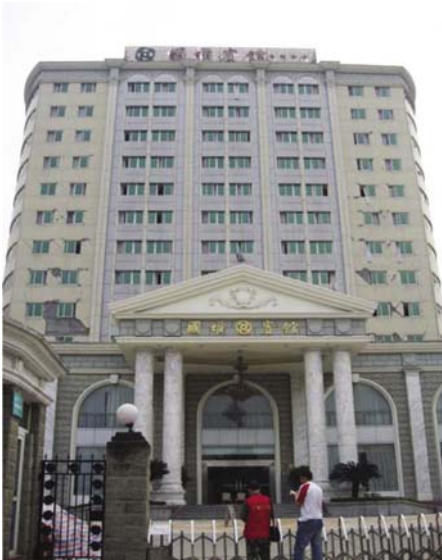
Fig. 13 RC frame structure, Guoyan Hotel (Group C, moderately damaged)

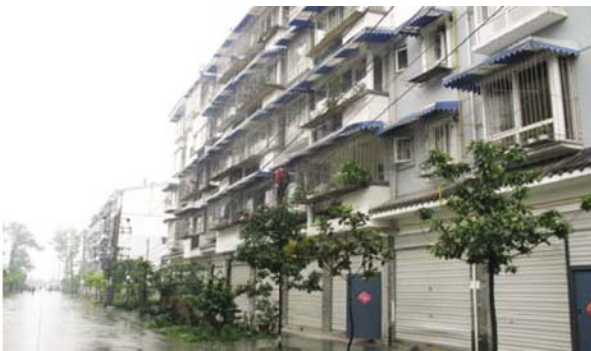
Fig. 14 Masonry residential building in Gaoqiao District (Group C, negligibly damaged)

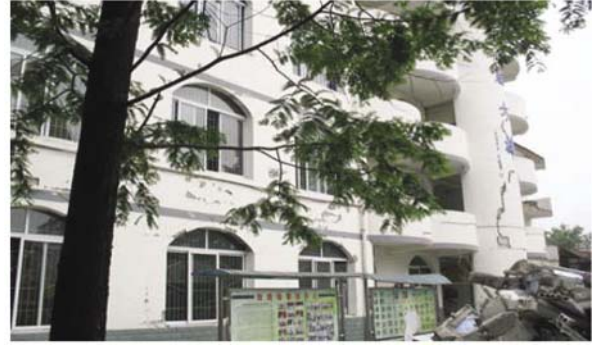
Fig. 15 Masonry laboratory of Juyuanzhen Middle School (Group C, seriously damaged)

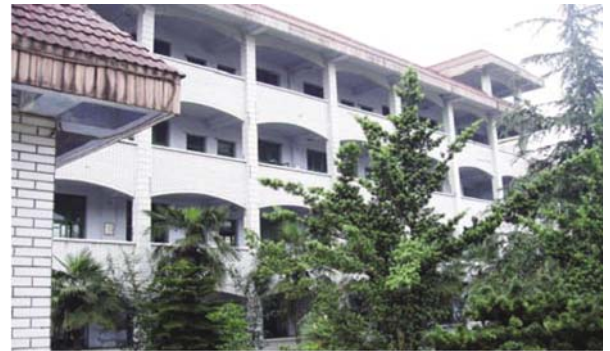
Fig. 16 Masonry building of Tazhonglianzhong School (Group C, moderately damaged)

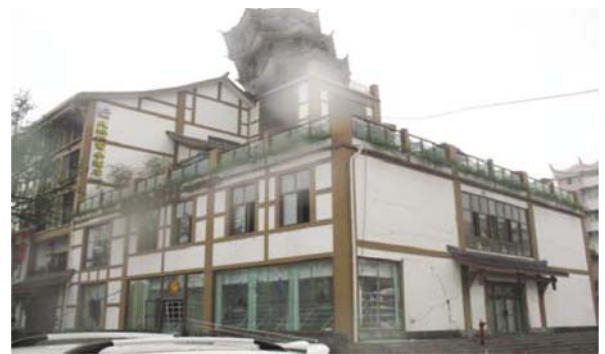
Fig. 17 Tiandiren Hotel (Group C, top building collapsed)
