Damage investigation of girder bridges under the Wenchuan earthquake and corresponding seismic design recommendations

Li Jianzhong[†], Peng Tianbo[‡] and Xu Yan^{!‡}

State Key Lab for Disaster Reduction in Civil Engineering, Tongji University, Shanghai 200092, China

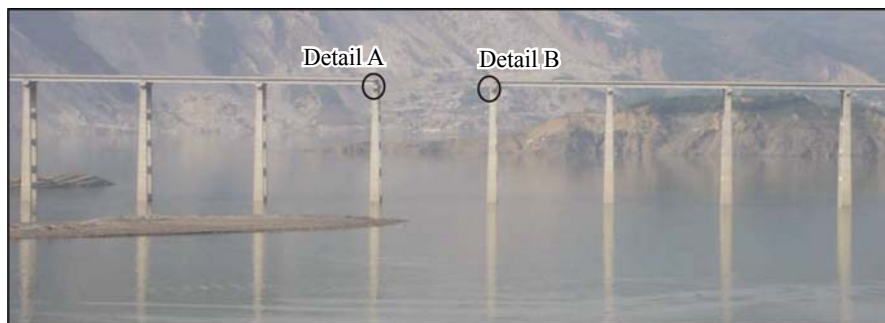
The Miaoziping Bridge is a long span-high pier bridge (see Fig. 2) near the Doujiangyan Ziping Dam, located 29 km from Yingxiu town, the epicenter of the Wenchuan earthquake. The main span consists of a continuous rigid frame 1.436 km long, with the highest pier over 108 m. The approach span consists of 50 m×19 spans simply supported girder with a continuous bridge deck. Each span was assembled with 10 pieces of T-shaped girder, weighing 140 t each. When the earthquake occurred, this bridge was not yet ready for traffic, as only the main structure had been completed. Due to the large relative displacement induced by the earthquake between the girder and the piers, the girder at the expansion joint of the fifth span of the approach bridge fell off, as shown in Fig. 3.

The span collapse of Miaoziping Bridge was mainly due to the large relative displacement between the girder and the pier induced by the earthquake. However, the structural configuration details of the supporting system may also have had some influence on the span collapse. Since the bearings were placed on the supporting concrete pads, the seating widths between the girder and the pad were much less than between the girder and the pier, causing the span to collapse once the displacement of the girder exceeded the seating width between the girder and the pad.

(a) Collapse of the fifth span

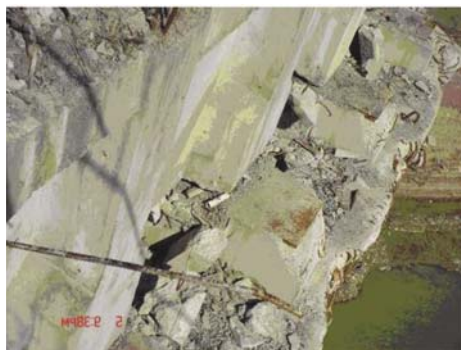
As shown in Figs. 3(b) and 3(c), laminated-rubber bearings were placed on the supporting concrete pads, the seating width between the girder and the pad is about 60 cm, and no longitudinal restrainers were used to prevent unseating. Since there was no connection between the bottom of the girder and the bearing, when the inertial force of the girder became larger than the friction force provided by contact between the girder and the bearing, relative sliding occurred. When the relative displacement became larger than the seating width, the

(b) Detail A (at expansion joint)

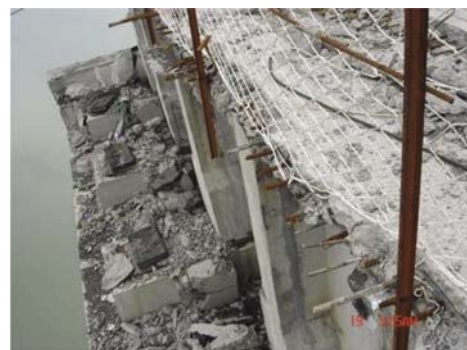
fifth span of the approach bridge fell off during the earthquake. Figure 3(c) also shows the damage at the supporting concrete pads and the edge of the pier caused by pounding due to collapse of the span.

(c) Detail B (at bridge deck)

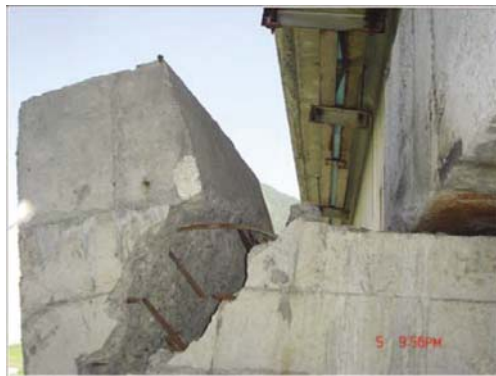
Other parts of the Miaoziping Bridge also suffered damage due to this earthquake. The damaged shear keys and bearings at the link pier are shown in Fig. 4.

(a) Shear key damage

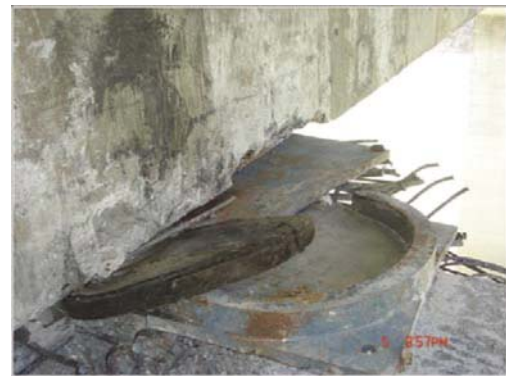
(b) Bearing damage

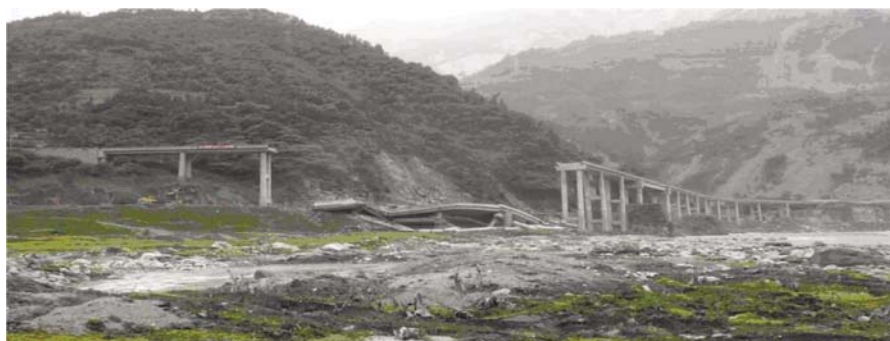
earthquake caused the collapse of the bridge; however, its design and geometrical configuration exacerbated the damage.

Once the displacement exceeded 60 cm, the end of the girder collapsed; meanwhile, due to a very low ratio of hoop reinforcement in the piers of this bridge (0.048%–0.067%, far less than required by

**Fig. 5 Failure of the Baihua Bridge**

the specification (1990) and larger than 0.3% at the bottom of the pier), the 17th pier could not handle the added axial force and bending moment caused by the imbalance created when the girder fell, so the entire fifth segment collapsed.

Although the strong earthquake is the main cause of this severe damage, the non-uniform distribution of mass and stiffness, the lack of longitudinal and transverse restrainers to prevent unseating at the in-span hinge, and the low hoop reinforcement ratio also significantly contributed to the damage. AASHTO (2007) has very clear requirements of less than 0.5 for the stiffness ratio of all piers in one segment and 0.7 for any two segments, and requires longitudinal and transverse restrainers to

prevent unseating at the in-span hinge. However, these requirements were not considered in the design of the Baihua Bridge.

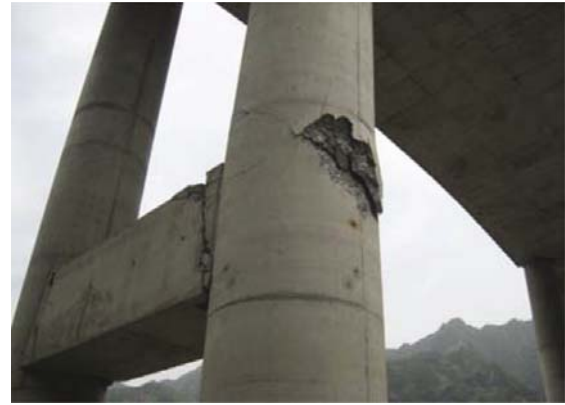
The Baihua Bridge is located at K1009 + 1009 + 691 km on the National Highway 213, at the upper wall of the main central fault (Beichuan-Yingxiu fault), only 2 km from Yingxiu Town. This bridge was constructed in December, 2004; the substructure was designed with the column pier connected by lateral braces. The bridge is 495.55 m long and its highest pier is 30.87 m. The superstructure is composed of 25 m × 4 Reinforced Concrete (RC) continuous spans, 25 m × 5 RC continuous spans, 50 m simply supported T beam, 25 m × 3 RC continuous spans, 20 m × 5 RC continuous spans, and 20 m × 2 RC continuous spans, as shown in Fig. 5. The horizontal line shape of the bridge consists of a 150 m radial curve (left) and a 66 m radial curve (right). The fifth segment, i.e., the 20 m × 5 RC continuous spans, completely collapsed (see Fig. 5). Other piers and joints where the lateral braces meet were also damaged, and large girder displacements and destruction of the expansion joints were observed. Typical damage is shown in Figs. 6 and 7.

Fig. 6 Column joint failure

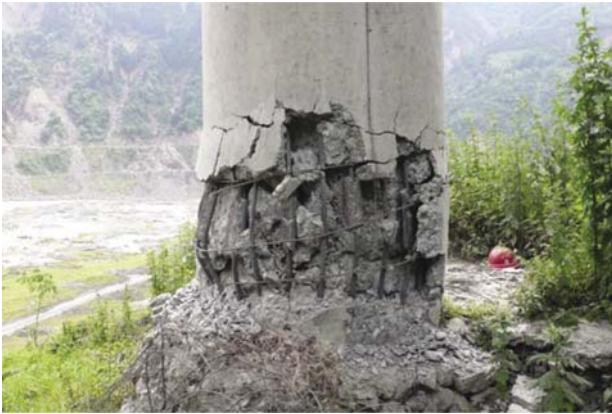
(a) Confinement failure

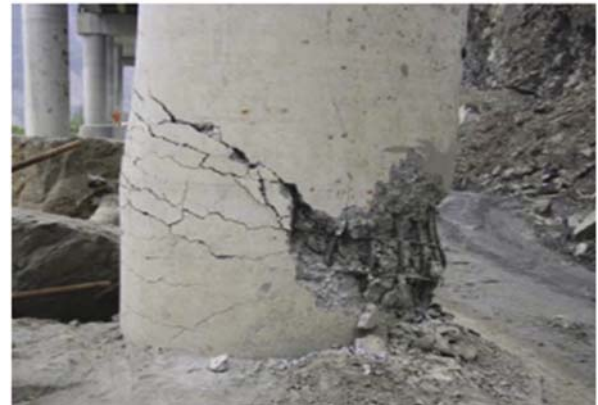
(b) Shear failure

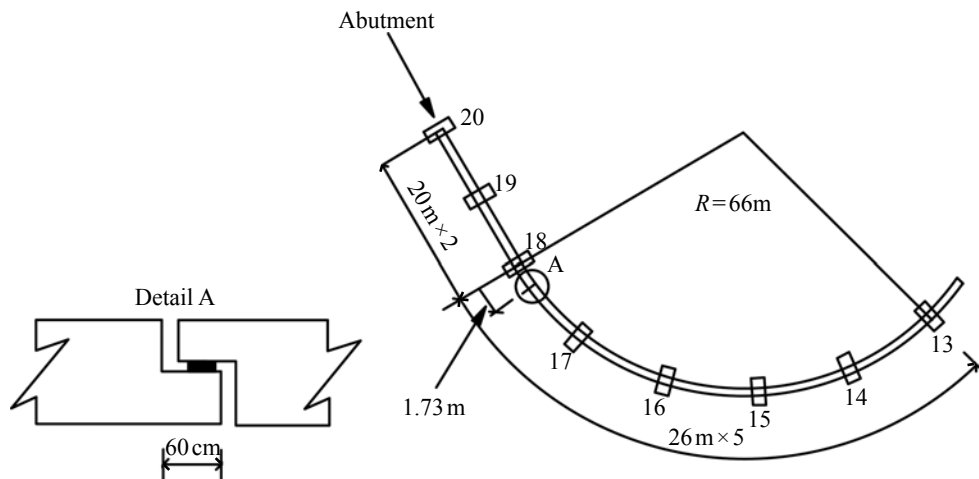
Fig. 8 Plan view of the fifth and sixth segments of the Baihua Bridge

Figure 8 shows the plane configuration of the fifth and sixth segments of the Baihua Bridge. The sixth segment consists of 20 m × 2 RC beams, with bilateral sliding bearings on the abutment and a fixed bearing on the 19th pier. The fifth segment consists of 20 m × 5 RC beams with a fixed bearing on the 16th pier, located on a 66 m radial curve. The left end of the fifth segment is supported on the in-span hinge with seat type located 1.73 m from the 18th pier, and the right end is supported by bilateral sliding bearings on the top of the 13th pier. Table 1 shows the heights of each pier of the fifth and sixth girder segments.

As seen in Table 1, the pier placed on the fixed bearing of the fifth segment is nearly three times higher than the sixth segment, which can result in a large difference in stiffness and dynamic characteristics. The out of phase vibration between the fifth segment and the sixth segment caused the large relative displacement at the in-span hinge.

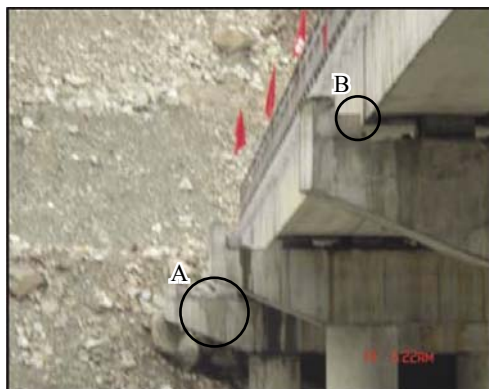
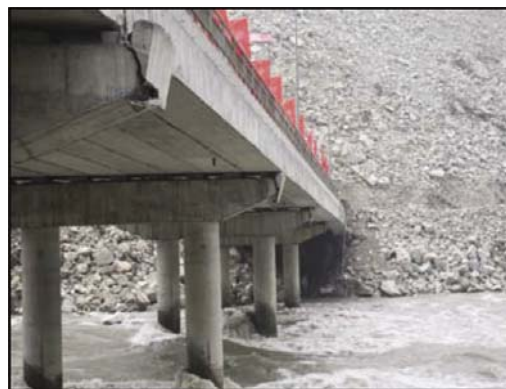
(a) Upstream at Wenchuan side

(b) Downstream at Wenchuan side

Fig. 10 Girder rotation of the Minjiang Bridge in Yingxiu

continuous RC slab bridge as shown in Fig 9. The skew angle is 80° , which refers to the angle between the longitudinal continuous main slab and the lateral pier cap. During the earthquake, the slab on the Yingxiu side (left side of the figure) moved 0.8 m in the upstream direction, and the slab on the Wenchuan side moved about 2.0 m in the downstream direction. The slab moved totally off the bearings, and the shear key was also damaged (see Fig. 10).

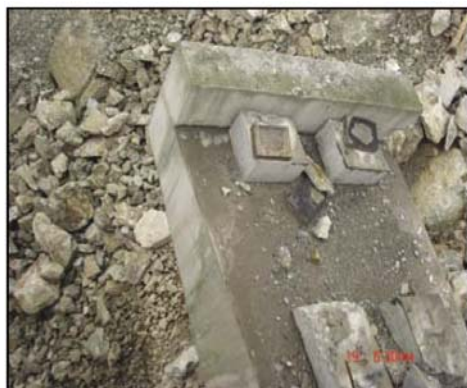
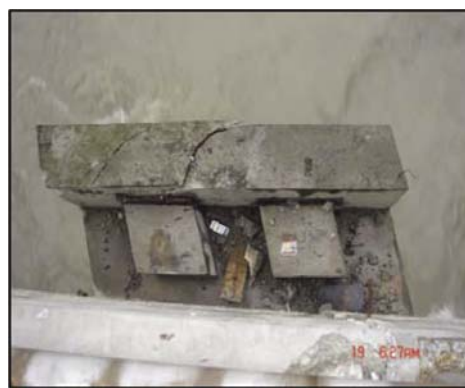
(c) Exposed bearings (at location A)

(d) Exposed bearings (at location B)

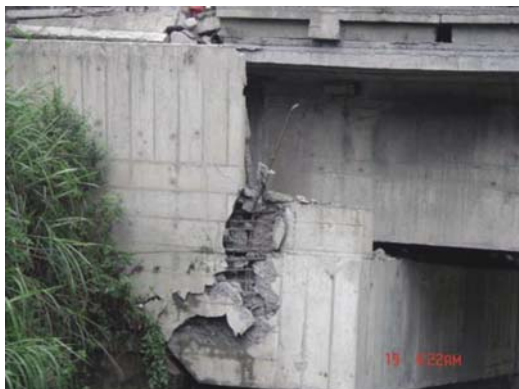
After the earthquake, the left abutment moved laterally, causing lateral and longitudinal displacements of the 30 m span, causing it to be in danger of collapse.

The left and right ends of the T-shaped girder of this span moved 50 cm and 60 cm, respectively, toward the abutment. The T-shaped girder fell off the bearings on the top of pier No. 1 and did not have any support on the

(a) Lateral displacement of girder at abutment

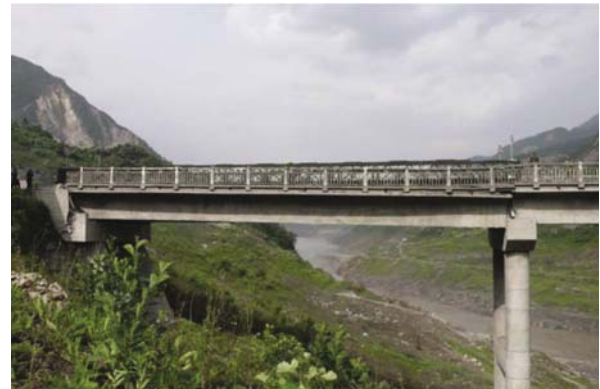
right side, and was supported by a length of less than 10 cm in the middle by the pier cap, as shown in Fig. 12.

(b) Collapse of the bearing of girder at pier 1

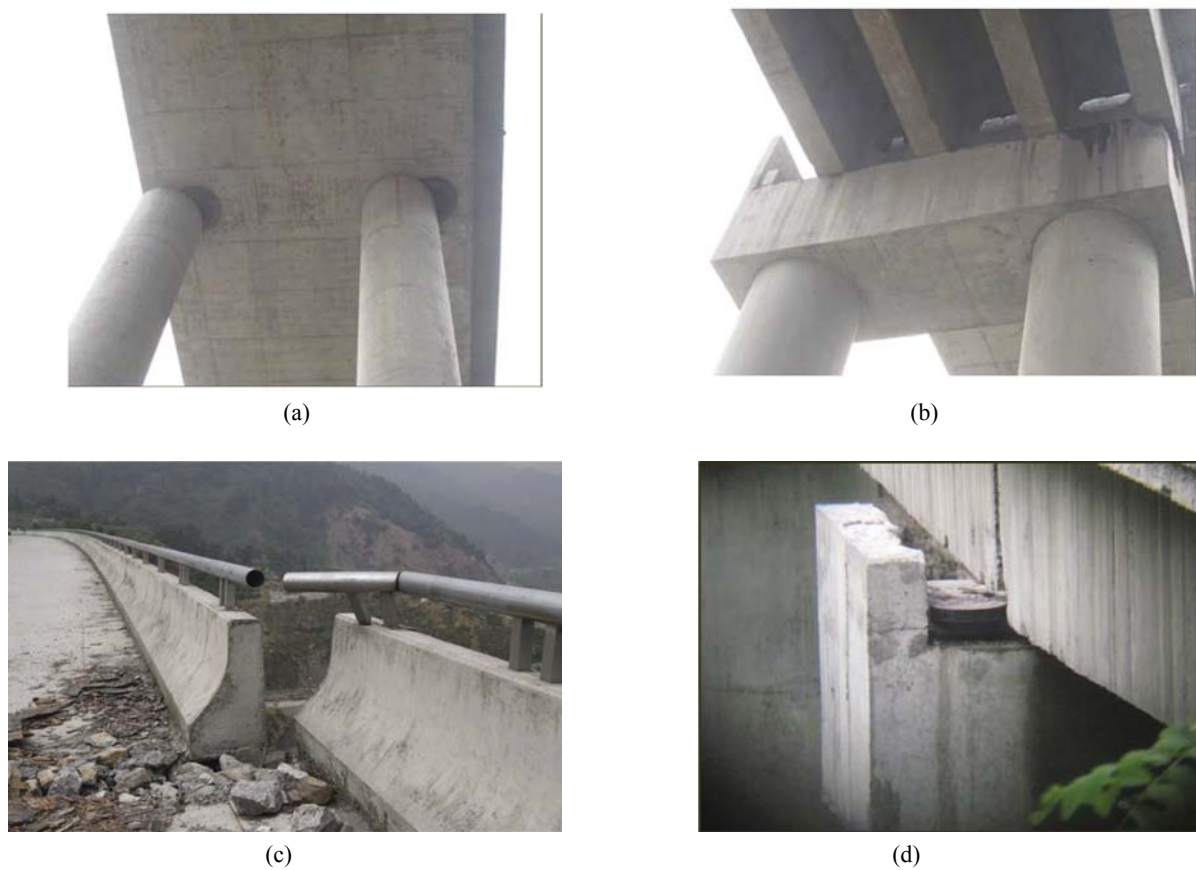
The most common damage to bridges caused by the Wenchuan earthquake was sliding between the girder and the bearing and large displacement of the girder, as shown in Fig. 13.

Fig. 13 Sliding between the top of the laminated-rubber bearing and the bottom of the girder

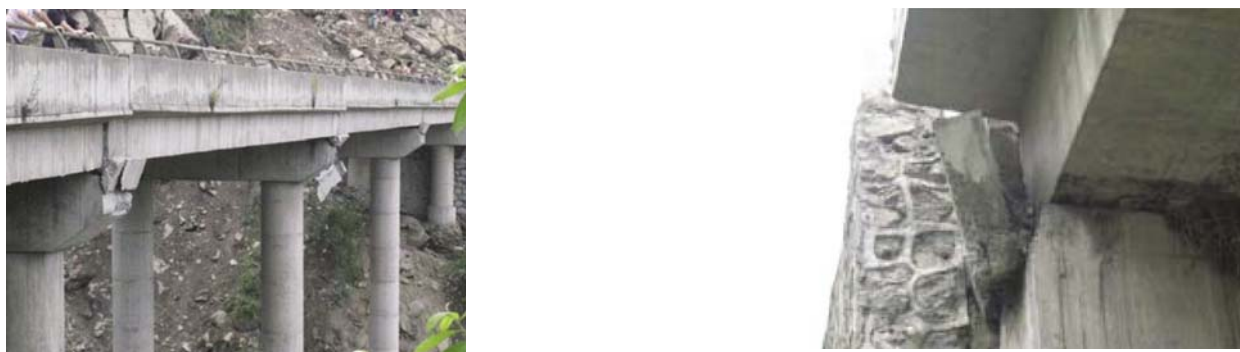
Due to the large displacement induced by sliding between the girder and the bearing, most lateral shear keys and expansion joints of the bridges described in this paper suffered some damage. Typical damage is shown in Figs. 14 and 15.

However, damage to the shear key can be beneficial to the pier and foundation. If the shear key was designed to be very strong, the inertial force of the superstructure will be transferred directly to the pier and foundation, causing more damage to the substructure. Of course,

Fig. 14 Typical shear key damage

if the shear key was not strong enough to prevent the girder from falling of the span, the design would not be appropriate. Therefore, finding a method to determine the appropriate stiffness and strength of the shear key in seismically active areas needs further research.

(3) For bridges with laminated rubber bearings without connections between the bearing and the girder, the shear key should be designed as a fuse to mitigate the seismic response of the substructure. However for these bridges, it is difficult to design the restrainers and provide adequate seating widths to prevent span collapse, while at the same time mitigating the seismic response of the piers.

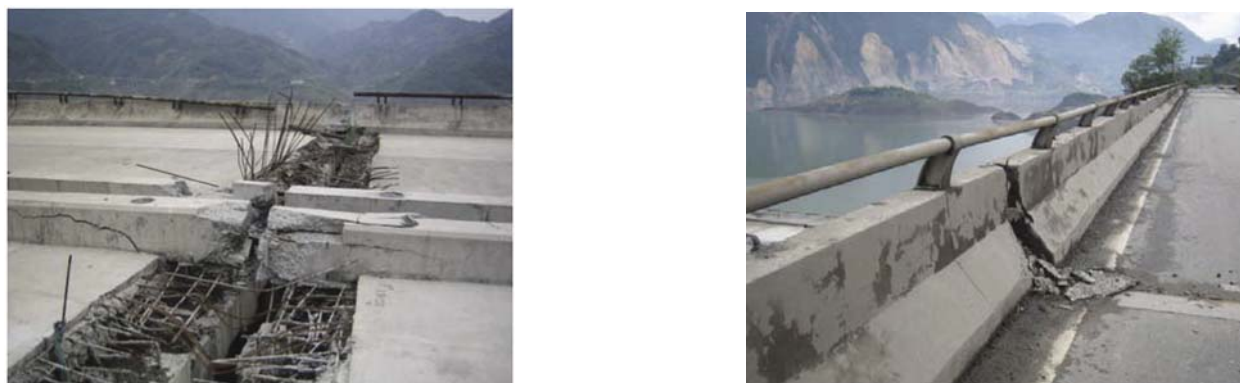
Fig. 15 Typical expansion joint damage

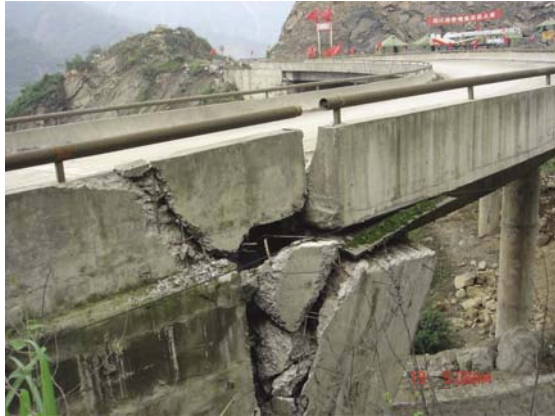
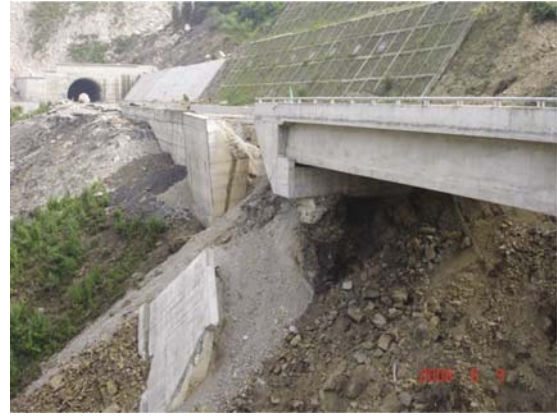
Typical damage to abutments included cracking of the abutment itself and damage to the back fill and retaining wall, as shown in Fig. 16.

Fig. 16 Abutment damage
