Revision of seismic design codes corresponding to building damages in the “5.12” Wenchuan earthquake

Wang Yayong[†]

Institute of Earthquake Engineering, China Academy of Building Research, Beijing 100013, China

Keywords: Wenchuan earthquake; earthquake damage to buildings; revision of seismic design codes

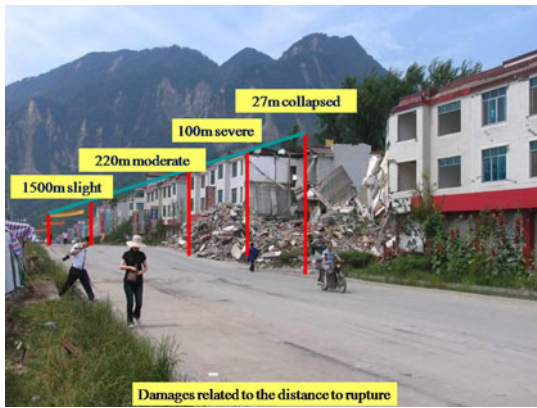
Figure 1 shows totally collapsed buildings in a range of 27 m wide along the rupture line, and an area of about 220 m wide, where moderate to severe damage occurred. This indicates that the location of buildings should meet a requirement of a minimum distance of 200 to 300 m from the earthquake rupture issued by the code. Not long after the event, a heavy rain fell for two days on September 23–24, 2008, which induced a turbulent debris flow from the mountain area, sweeping Beichuan County and burying many streets and buildings. The debris cover was 6 m at shallow sites to over 40 m at its deepest. Figure 4 shows a four-story apartment building buried by the mud flow.

Fig. 1 Collapses induced by rupture slipping on the ground (Photo from Yuan Yifan)

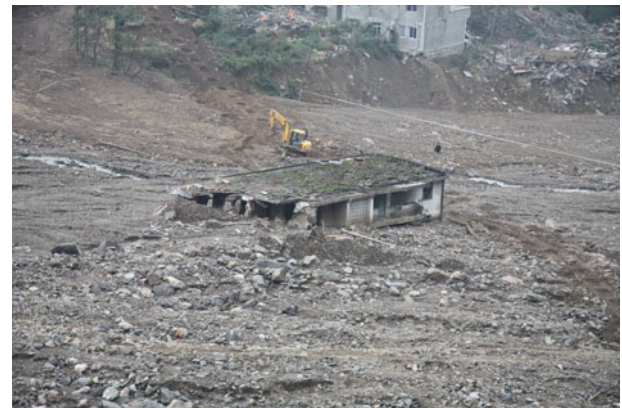
Fig. 4 Apartment building mostly buried by debris flow late Sept. in Beichuan County

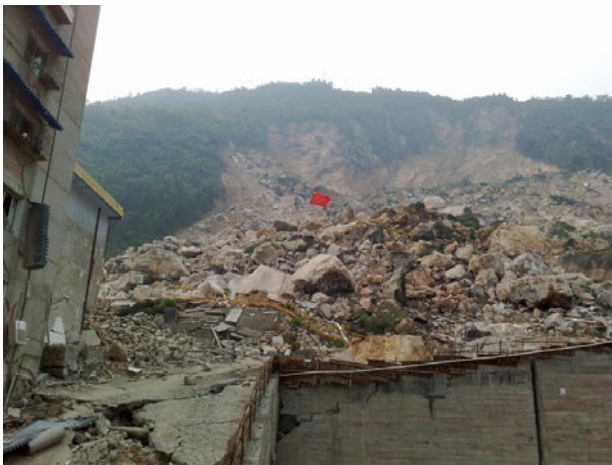
Fig. 2 Maoba High School buried by a rock slide in Qushan Town, Beichuan County

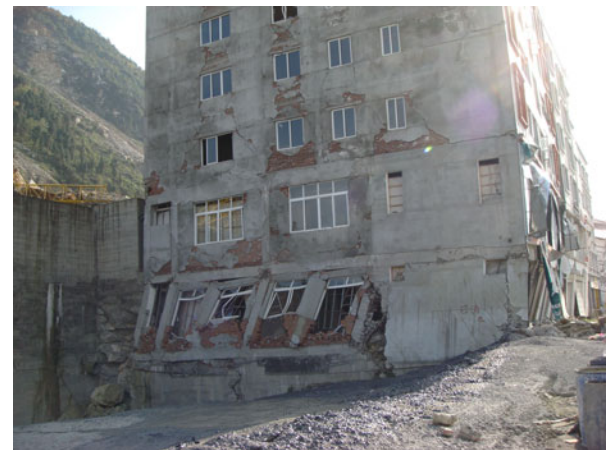
Fig. 5 Bottom frame structure severely damaged due to failure of slope wall

Figure 5 shows a failure of the bottom frame structure of a complex building used for commerce and residential purposes in Beichuan County, where severe damage was caused by pressure from the retaining wall.

Retaining walls are required by the 2008 Code for construction in mountainous areas. Space between the building foundation from the foot of a hill is also specified in the 2008 Code. It is very dangerous and forbidden to locate a building on a retaining wall.

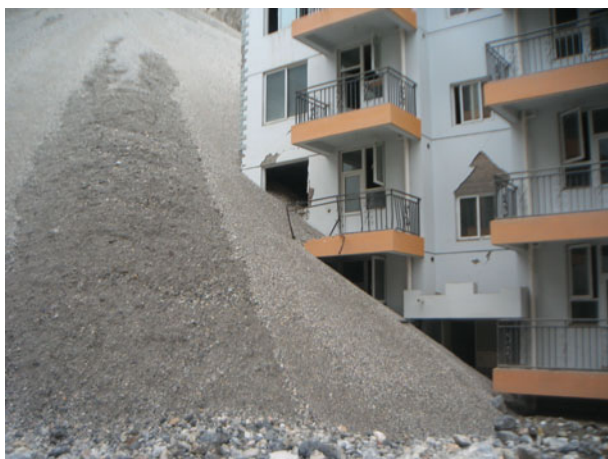
Fig. 3 Apartment building partially buried by landslide in Wenchuan County

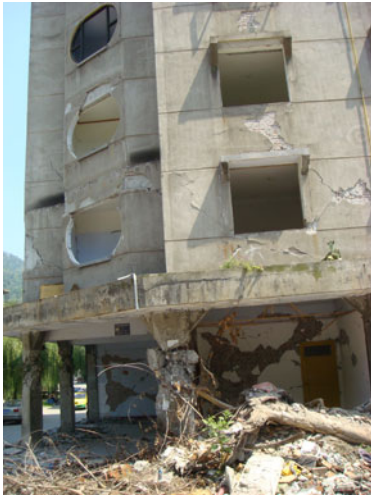
Fig. 6 Damaged RC bottom frame structure (0.1g/0.4g). Note: (0.1g/0.4g) = (specified PGA/estimated PGA)

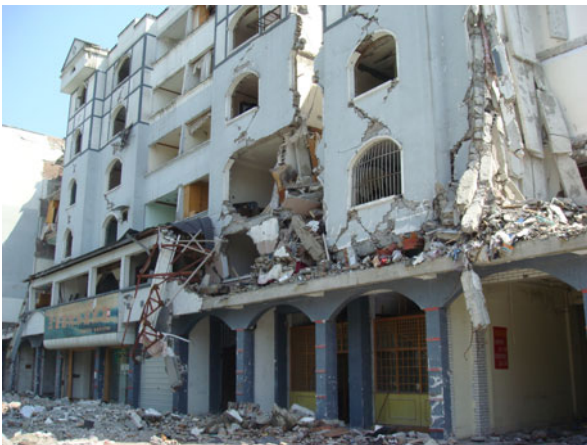
Fig. 7 Damaged upper walls of masonry building with RC bottom frame structure (0.1g/0.4g)

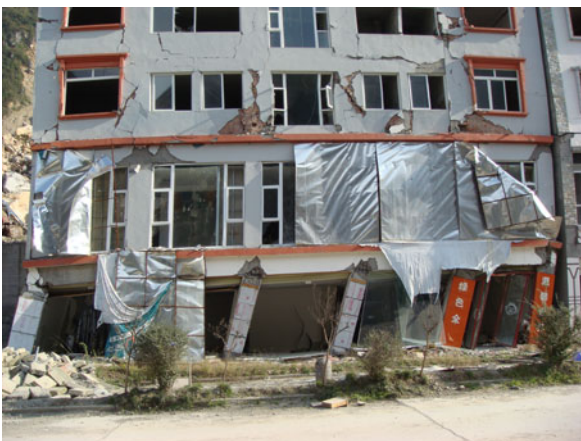
Fig. 8 Damaged masonry building with two-story RC bottom frame structure (0.1g/1.0g)

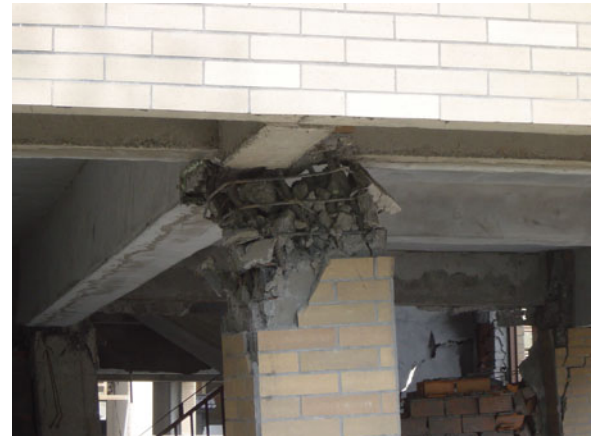
Fig. 9 Plastic hinges on top of a column (0.1g/0.3g) (Photo from Yao Qiulia)

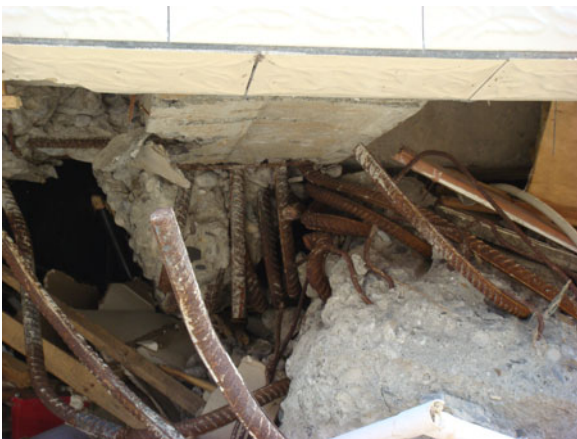
where $\eta_c = 1.1, 1.2, 1.4$, respectively, for different grades of RC columns. However, in practice, the goal of strong column and weak beam cannot be achieved because the flexural stiffness of the beam is multiplied simply by a factor of 1.5–2.0 to consider the area where the floor slab joins with the beam while calculating the moment at the ends of the beam. In the “5.12” Wenchuan earthquake, the failure of many RC frame structures was due to problems associated with a “strong beam and weak column. Figure 9 shows the failure mechanism of a six-story RC frame structure in Dujiangyan City. Plastic hinges can be seen at the top of the column of the ground floor, but beams and slabs remained undamaged. Figure 10 shows a collapsed RC frame structure in Beichuan County, the epicenter area, where it can be seen that the reinforcement ratio of the beams was much larger than the columns.

Fig. 10 Less reinforcements to column than beam (0.1g/1.0g)

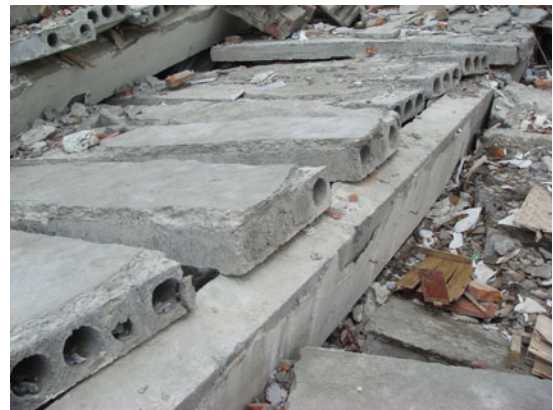
The field survey revealed that pre-cast floor and roof slabs might collapse if the support wall or beam was broken or large horizontal displacement occurred due to poor detailing of the joints and structural integration. Figure 12 shows a completely collapsed three-story primary school masonry building. There was no connecting detail between either the slab & beam or the slab & slab. Figure 13 shows a partially collapsed five-story masonry school building that lacked the required RC tie- column and boundary-beam.

Fig. 12 Collapsed pre-cast RC floor slabs (0.1g/0.2g)

Therefore, the 2008 Code has regulated that reliable measures to ensure the integrity of the connection joint among pre-cast RC slabs of the floor and roof system be mandated.

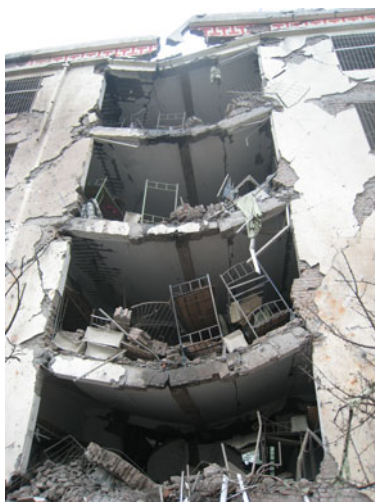
The floor and roof systems integrated with cast-in-situ RC slabs performed well in cases of large deflection, which have been commonly used in multi-story and tall buildings. In the 2008 Code, the use of cast-in-situ RC floor slabs was encouraged for large masonry schools and hospitals. Figure 11 shows the collapsed ground floor and internal walls of a five-story student hostel building made of masonry. Note that the cast-in-situ RC floor slab remains with large deflection.

Fig. 11 Large deflection of floor formed with cast-in-situ RC beams and slabs (0.1g/1.0g)

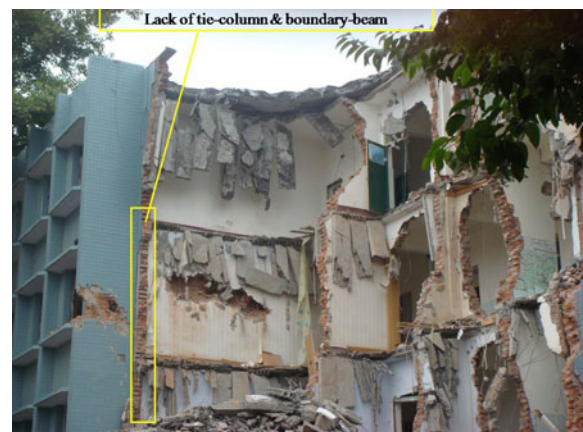
Fig. 13 Partially collapsed masonry structure due to lack of required tie-column and boundary-beam (0.1g/0.3g)

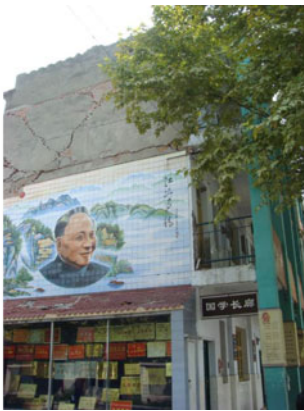
The goal of collapse prevention can be achieved even for pre-cast RC structures if the connection details between slabs, slab & wall, and slab & support beam are properly designed and constructed. Figures 14–16 show a three-story masonry school building which was subjected to earthquake forces scaled at an estimated seismic intensity of four times the specified intensity. The building was severely damaged but remained standing due to the excellent connection between the RC slabs and tie-beams surrounding each floor and the roof.

Fig. 14 Severely damaged three-story masonry school building (0.05g/0.20g)

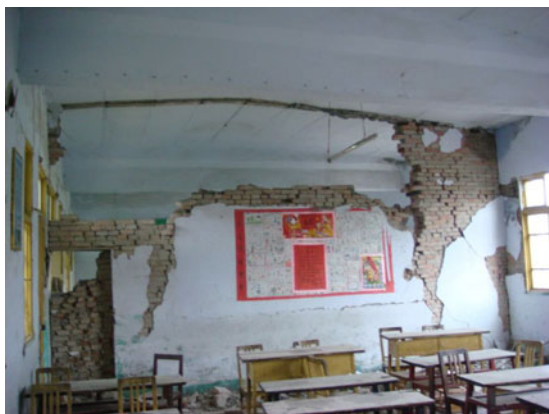
Fig. 15 Collapse of transverse wall (0.05g/0.20g)

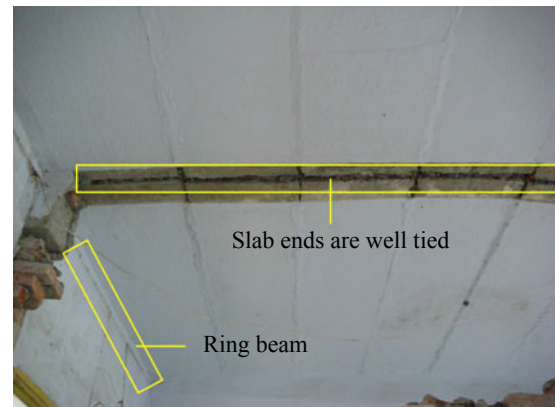
Fig. 16 Stable floor of pre-cast slabs with excellent joints and tie-beams (0.05g/0.20g)

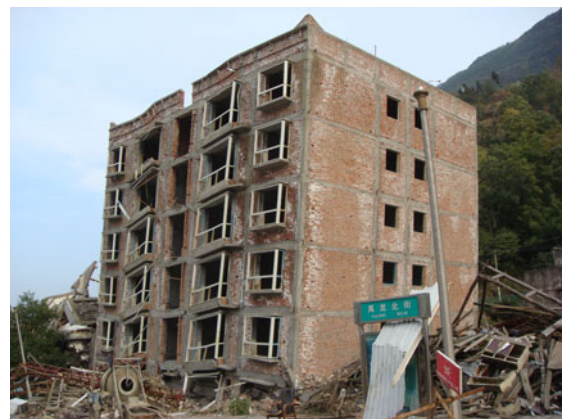
The ground motion in the epicenter area was so strong that the bottom floor of many structures suddenly collapsed at the moment of the initial arrival of the earthquake wave, and therefore the ground motion could be isolated by the collapsed layer to save the upper stories from severe failures. Figure 17 shows a confined masonry apartment building located in Beichuan County, in the epicenter area. The two bottom-stories were destroyed and suddenly collapsed by the first shock at the initial arrival of earthquake wave, but the five upper stories remained intact.

Fig. 17 Two bottom stories collapsed and five upper stories remained standing, Beichuan County (0.1g/1.0g)

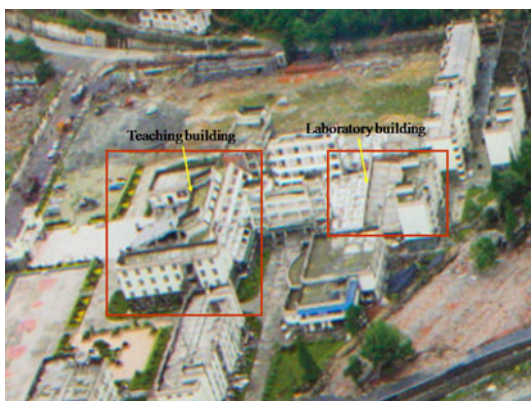
Figure 18 shows the Xuankou High School before the event in Yingxiu Town, Wenchuan County. The five-story teaching building and laboratory were constructed of two-bay RC frame structures with some redundancy. Fortunately, more than 1,200 students escaped from these two buildings, which survived the main shock with an intensity of over 11 degrees ($PGA \approx 1.0 g$) in the epicenter area. The teaching building partially collapsed and the laboratory totally collapsed in the aftershock (see Figs. 19–21).

Fig. 19 Damaged Xuankou High School (0.1g/1.0g)

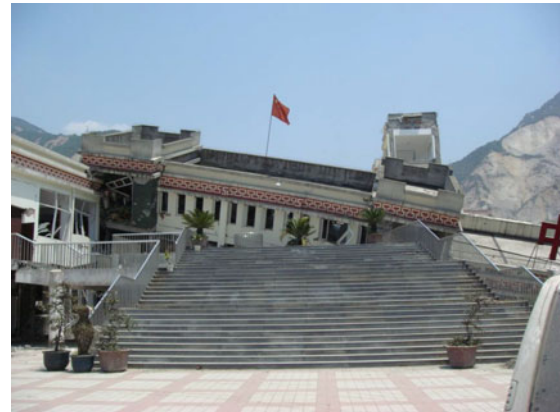
Fig. 20 Partially collapsed teaching building (0.1g/1.0g)

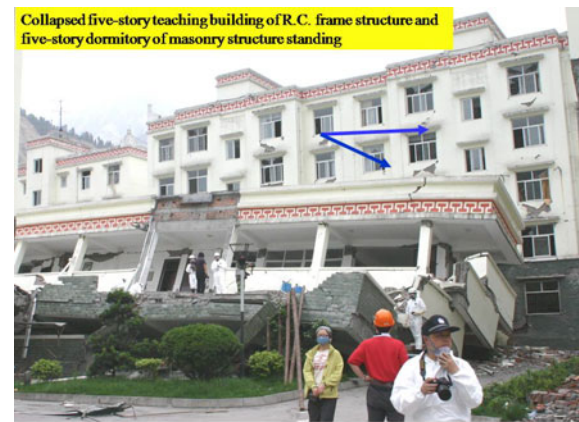
Fig. 21 Totally collapsed laboratory building (0.1g/1.0g)

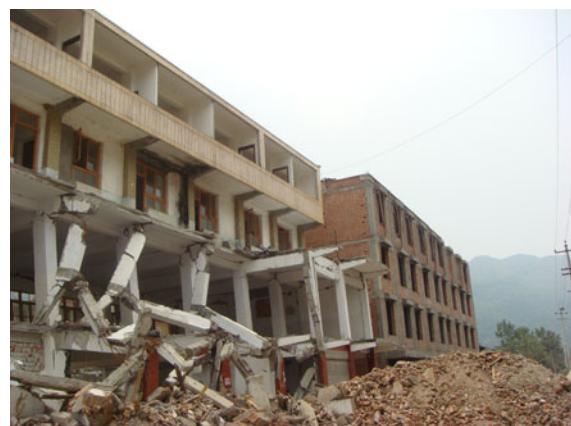
For example, there was a four-story RC single-bay frame hospital structure and a masonry residential structure located side by side at the site of an effective seismic intensity of 9 degrees (PGA = 0.40 g) in Nanba Town, Pingwu County. The seismic design was based on the specified intensity of 7 degrees (PGA = 0.10 g), which was much lower than the estimated actual intensity at the site. The hospital building was severely

damaged and nearly collapsed, while the residential building survived due to the excellent confinement of the masonry structure (see Figs. 22–24).

Fig. 22 Damage to two nearby buildings (0.1g/0.4g)

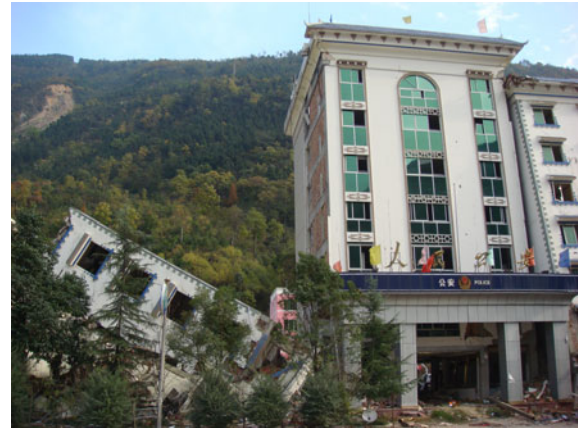
and building height. The upper structures at both sides of the partition should be completely separated to avoid knocking. However, it is not necessary to set partitions for any irregular building. The 2008 code requires that the width of a partition be large enough to avoid collision of the upper structures during earthquakes that may result in a sequential collapse. Figures 25–26 show an example of a sequential collapse of buildings in Beichuan County, the epicenter area. The commercial buildings on the left side of the street sequentially collapsed due to knocking from the office building on the right side of the street.

Fig. 25 Collision between an office building and apartment buildings in Beichuan County (0.1g/1.0g)

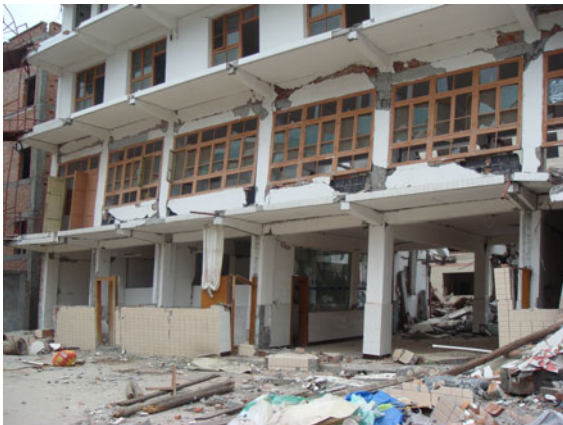
Fig. 23 Severely damaged four-story RC single-bay frame single span hospital building (0.1g/0.4g)

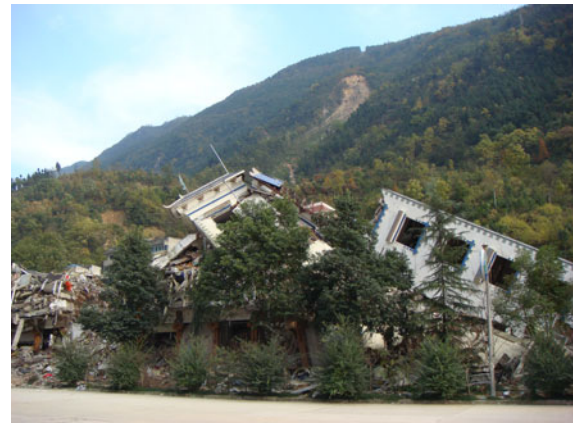
Fig. 26 Sequential collapse of commercial buildings in Beichuan County (0.1g/1.0g)

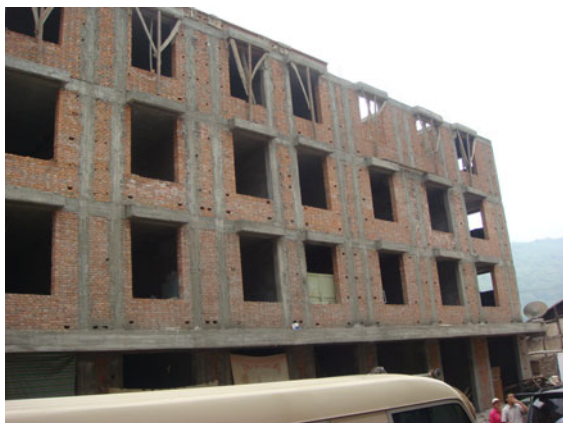
Fig. 24 Good performance of four-story confined masonry apartment building (0.1g/0.4g)

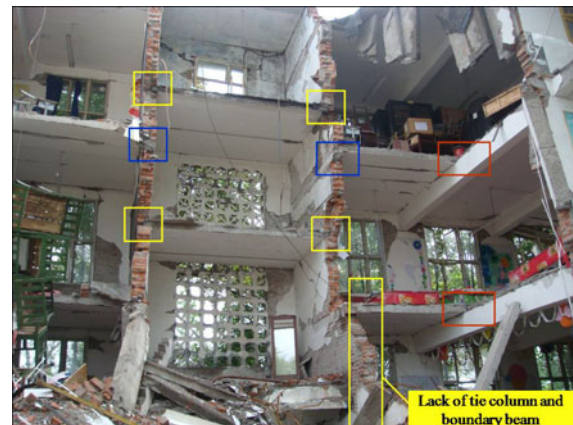
platform beam, and the RC tie-columns should expand up to the top of the stair shaft above the roof. Figure 27 shows a severely damaged three-story masonry teaching building. The stair shaft collapsed due to a lack of tie-

Fig. 27 Collapsed stair shaft of a three-story school building in Mianzhu County (0.1g/0.3g)

The stair shaft, at the entrance and exit of buildings, provides the only way for people to evacuate and should therefore guarantee safety in the case of any disaster, including earthquake. Clause 7.3.1 of the 2008 Code stresses that RC tie-columns should be set up at the corners of stair shaft and exterior walls, ends of step beam, the joints of interior and exterior walls, etc. in masonry structures. Clause 7.3.8 again requires that the pre-cast step beam be appropriately connected with the

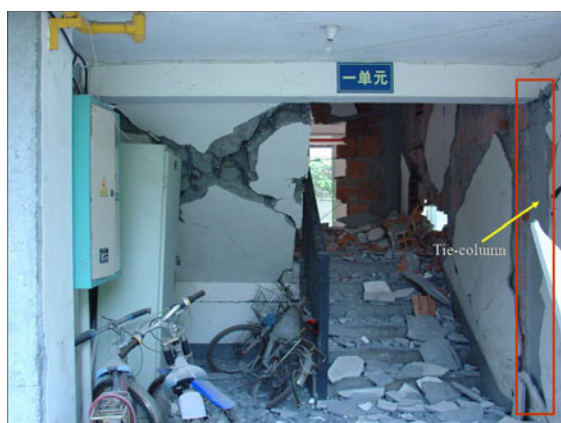
Fig. 28 Six-story masonry residence building remained stable with a severely damaged stair shaft (0.1g/0.3g)

columns at its corners. In contrast, Fig. 28 presents an example of a successful design. Although the brick walls and step beams of the six-story masonry residential building were severely damaged, the stair shaft remained stable because the tie-columns were appropriately set at the ends of the platform beam.
