A comparative study of bridge damage due to the Wenchuan, Northridge, Loma Prieta and San Fernando earthquakes

Wang Zhiqiang^{1,2†} and George C. Lee^{2‡}

Abstract: A comparative study of selected bridge damage due to the Wenchuan, Northridge, Loma Prieta and San Fernando earthquakes is described in this paper. Typical ground motion effects considered include large ground fault displacement, liquefaction, landslide, and strong ground shaking. Issues related to falling spans, inadequate detailing for structural ductility and complex bridge configurations are discussed within the context of the recent seismic design codes of China and the US. A significant lesson learned from the Great Wenchuan earthquake, far beyond the opportunities to improve the seismic design provisions for bridges, is articulated.

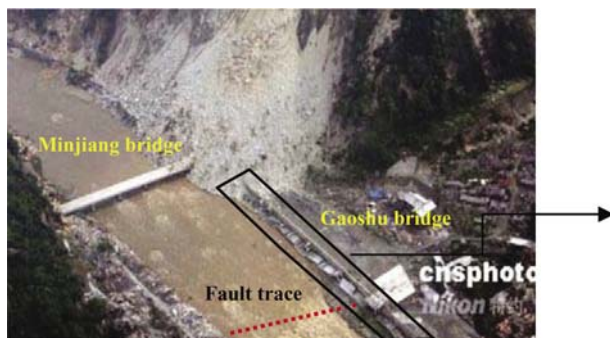
Fig. 1 Aerial view of Gaoshu and Minjiang bridges

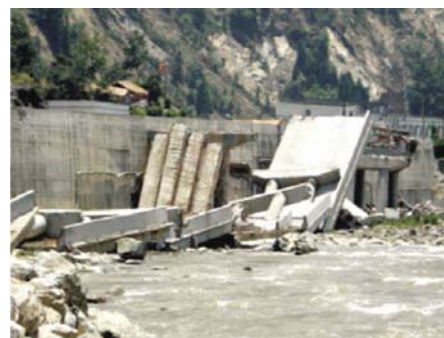
One important observation was the bridge failures due to large permanent ground deformations. One of these bridges was the Gaoshu Bridge, located in Yingxiu Town. The major fault trace was observed cross orthogonally oriented to the Gaoshu Bridge (see Fig.1). The vertical and horizontal displacements of the surface rupture were approximately 50 cm and 100 cm respectively. These large displacements directly lead to the collapse of the Gaoshu Bridge (see Fig. 2).

Fig. 2 Collapsed Gaoshu Bridge (Yuan *et al.*, 2008)

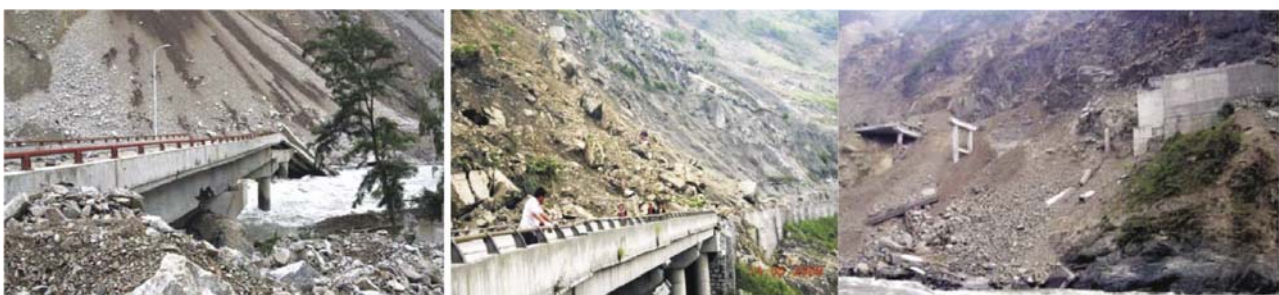
Some highway and bridge damage during the Wenchuan earthquake was the result of landslides. Much of the damage was quite spectacular. Figure 3 shows some bridges of Duwen Roadway that were pushed over by a large landslide. Since landslides are not normally covered in design bridge codes, this issue may need to be addressed in future code revisions.

Fig. 3 Three damaged bridges in Duwen Roadway induced by landslide or rockfall (Yuan *et al.*, 2008)

Some well-designed rock slope supports generally performed well, without noticeable signs of failure. Therefore, providing better retaining walls in mountainous regions would go a long way to keeping bridges open after earthquakes (although this is not always economically justified).

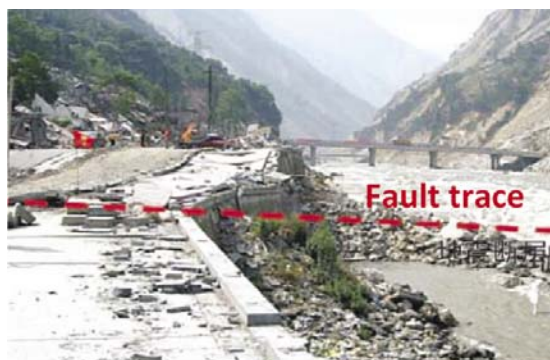
The Minjiang Bridge is located in Yingxiu County crossing the Minjiang River. It is a simply supported girder bridge with continuous slab. The superstructure is supported on rubber bearings. The Minjiang Bridge is located approximately 100 m from the fault and parallel to it. The girder moved transversely 1.8 m, and had a little torsion, but was not unseated. Because of the rubber bearings, the pier damage is less serious, as shown in Figs. 4 and 5.

Fig. 4 Minjiang Bridge nearby fault trace (Yuan *et al.*, 2008)

Damage and collapse of the Minjiang and Gaoyuan bridges suggest that near fault design requirements need to be revisited to improve the code.

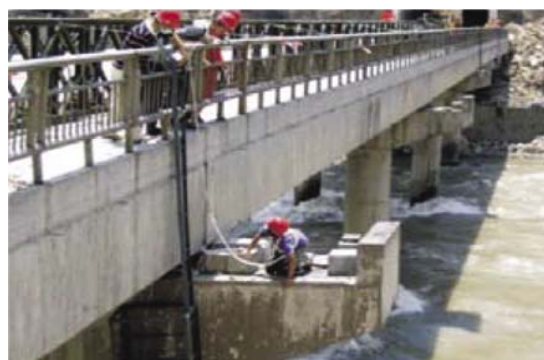
Fig. 5 Transverse displacement of girder (Yuan *et al.*, 2008)

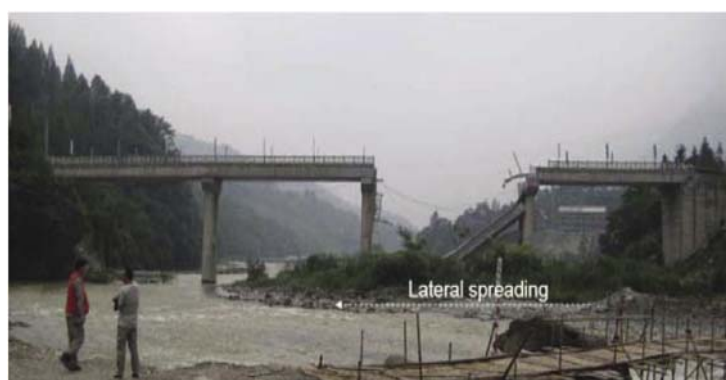
The Gaoyuan Bridge is a four span simply supported girder bridge with continuous slab. The girder rested on rubber bearings and between transverse stopper. Surface fault rupture also occurred in this vicinity. The third span from the left had been pushed off the pier cap and collapsed. Backwall and transverse stopper of the abutment in the Gaoyuan Village side were also seriously damaged, as shown in Figs. 6 and 7.

Fig. 6 Gaoyuan Bridge nearby fault trace (Chen, 2008)

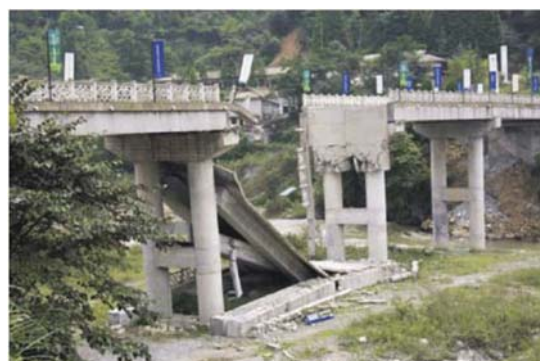
Fig. 7 Unseating of superstructure (Yuan *et al.*, 2008)

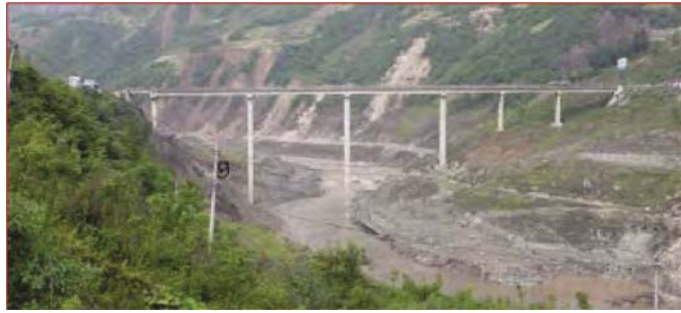
The Shoujiang Bridge is located in Xuankou County. It is a multiple span simply supported and slab continuous bridge. The pier height is more than 40 m. The main girder moved longitudinally with the side span nearly unseated. The wingwall and the backwall of the abutment were damaged as seen in Figs. 8–10. The extremely large displacement response of the Shoujiang Bridge may have been induced by the very high pier.

Fig. 8 Shoujiang Bridge (Li *et al.*, 2008)

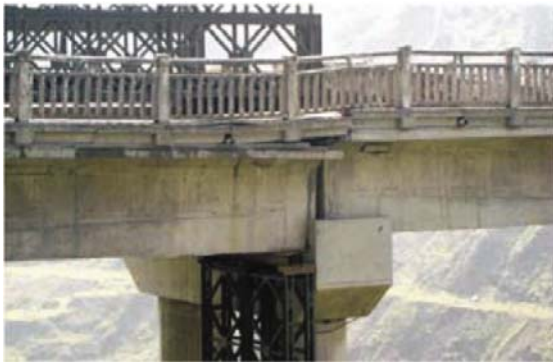
Fig. 9 Dislocated of superstructure (Yuan *et al.*, 2008)

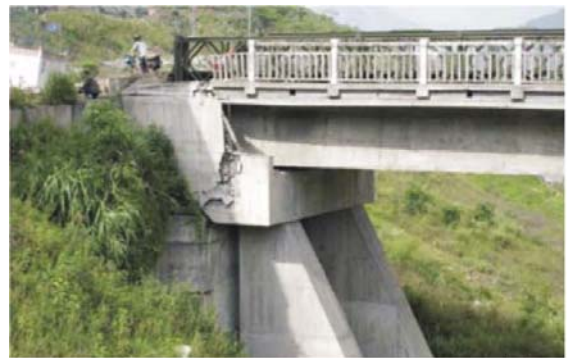
Fig. 10 Abutment damage (Yuan *et al.*, 2008)

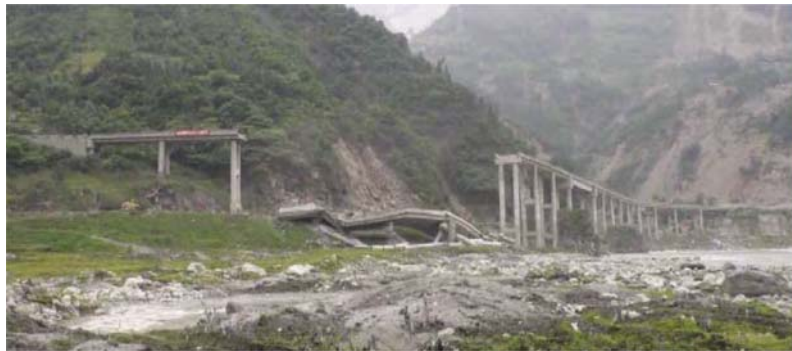
During the Wenchuan earthquake, at least two curved bridges collapsed; one is Baihua Bridge, and the other is Yuzixi Bridge (Figs. 11 and 12).

The Baihua Bridge is 495.55 m long and is supported by twin-column piers. The maximum pier height is 30.87 m. The superstructure rested on rubber bearings and pot bearings. The Baihua Bridge consisted of six segments. The construction was completed in 2004. It is located about 2–3 km from the fault.

Fig. 11 Collapsed Baihua Bridge (Li *et al.*, 2008)

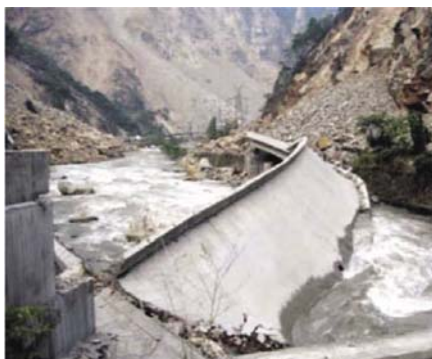
Fig. 12 Collapsed Yuzixi Bridge (Yuan *et al.*, 2008)

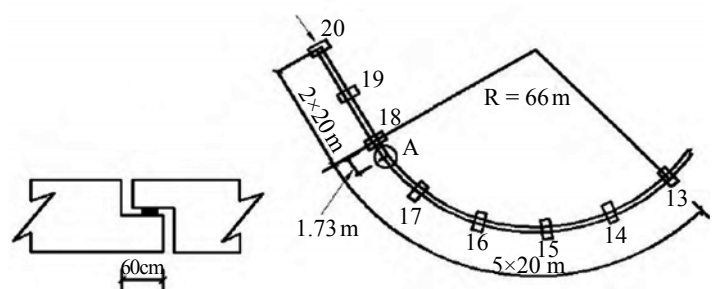
As can be seen from Figs. 13 and 14, the 5-curve span segment from pier 13 to 18 totally collapsed. It is believed that the girder first unseated from the top of pier 18 that initiated the collapse.

Fig. 13 Details of pier top of (Li *et al.*, 2008)

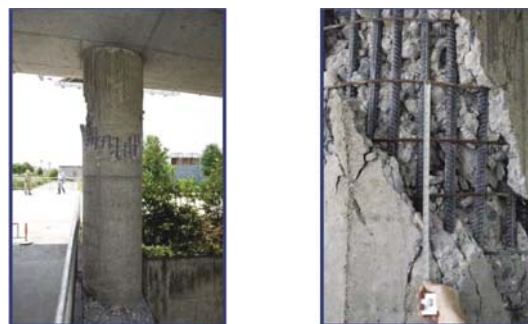
During the Wenchuan earthquake, damage to bridge piers was less serious than in the San Fernando, Northridge and Loma Prieta earthquakes. It is believed that the sliding of rubber bearings helped to reduce the base shear. On the other hand, there were poor reinforcing details and damaged rigid frame bridges, as shown in Figs. 15 and 16.

Both types of bridge damage seen in Figs. 15 and 16 suggest the lack of transverse reinforcement and inadequate concrete confinement.

Fig. 15 Shear failure of column of Mianyang Airport viaduct (Chen *et al.*, 2008)

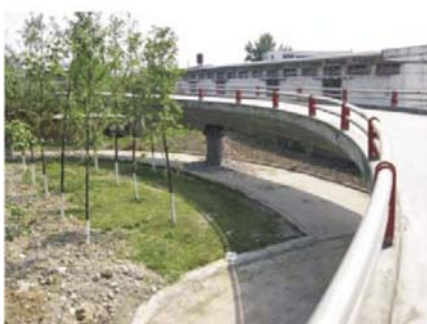
Fig. 16 Failure of column top of ramp of Huilan overpass (Yuan *et al.*, 2008)

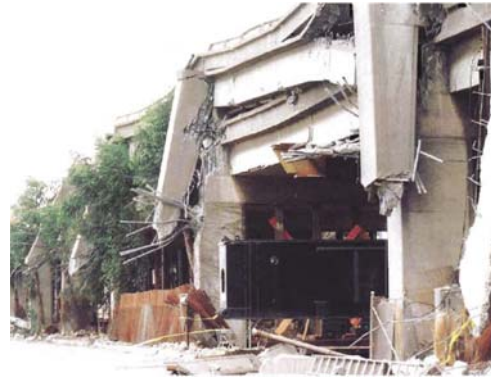
In the Loma Prieta earthquake, most of the bridges damaged were constructed prior to 1971. The most serious damage occurred to older structures located on soft ground. The most tragic impact of the earthquake was the life loss caused by the collapse of the Cypress viaduct (see Figs. 19 and 20). The Cypress viaduct

Fig. 19 Cypress viaduct (Housner *et al.*, 1990)

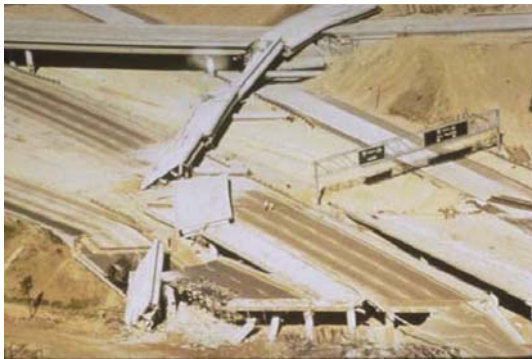
The collapse of five concrete bridges during the San Fernando earthquake initiated revolutionary changes in seismic design criteria and performance standards in the US. Decks that were pulled off their supports at expansion joints were the weak link for many bridges that existed in 1971. Figure 17 shows the overcrossing at the Golden State Freeway (I-5) and Foothill Freeway (I-210) interchange that carried southbound traffic from the Foothill Freeway onto the Golden State Freeway. The 770-ft. long box girder deck of this overcrossing was supported on six single-column piers with an abutment at each end. It had one expansion joint near the mid-span and two each at the two abutments. Separation at the centrally located expansion joint allowed one end of an adjacent span to fall off its support, which initiated the collapse of the entire structure (Seismic Safety Commission, 1994).

Fig. 17 Golden State Freeway (I-5) and Foothill Freeway (I-210) interchange (<http://www.smate.wvu.edu>)

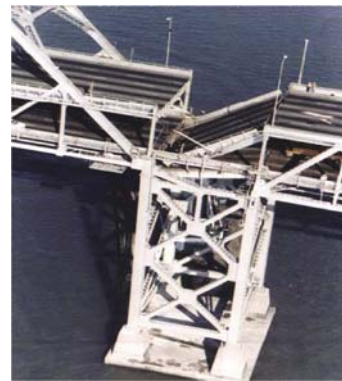
Fig. 20 San Francisco-Oakland Bay Bridge (Penzien *et al.*, 2003)

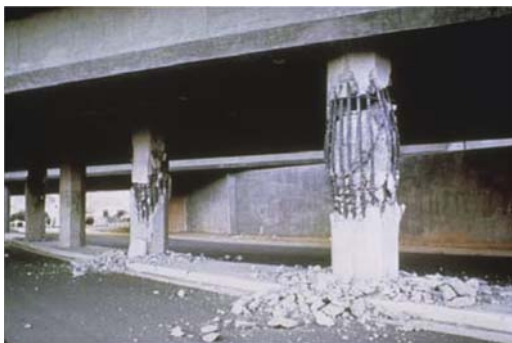
This earthquake also revealed certain deficiencies in RC columns, such as inadequate ties, both in size and spacing, as shown in Fig. 18.

Fig. 18 Foothills Freeway overpass (<http://ntl.bts.gov>)

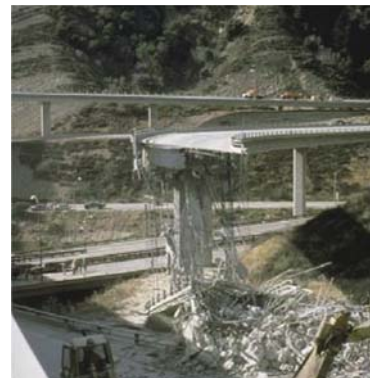
The Northridge earthquake caused the collapse or partial collapse of seven concrete freeway bridges and damaged many more. The two bridges of these bridges that collapsed at the SR-14/I-5 interchange, the North Connector Overcrossing and the South Connector and Overcrossing, were different from the structures at this same interchange that collapsed during the 1971 San Fernando earthquake. They were designed prior to 1971 but their construction was not completed until 1974 (Housner *et al.*, 1994), when it was believed that hinge restrainers would be adequate to prevent the type of collapse that occurred during the San Fernando earthquake. Therefore, pre-1971 design detailing

was followed in constructing these bridges but hinge restrainers were added to prevent the decks from failing off their narrow support seats. During the Northridge earthquake, brittle shear failures in short stiffer columns next to the abutments initiated collapse as shown in the Fig. 21.

Fig. 21 SR-14/I-5 interchange (<http://www.smate.wvu.edu>)

These failures clearly demonstrated that retrofitting such structures with hinge restrainers alone is inadequate. Large skews in geometry result in excessive torsional response during earthquakes; thus, they are detrimental to overall good seismic performance. Therefore, methods are needed for improved design of skewed bridges, possibly including elimination of the skew where feasible, elimination of in-span hinges, and lengthening of seats.

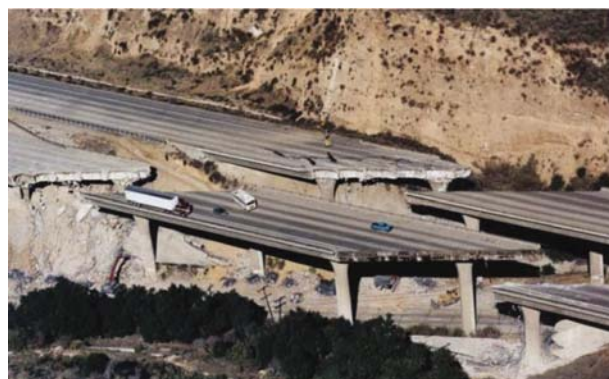
I-5 crossing Gavin Canyon on two skewed five-span bridges (Fig. 22) was constructed in 1967. Cable restrainers had been installed across the hinge seats in a 1974 retrofit (Housner *et al.*, 1994). Displacements were very large to cause the loss of bearing support at the hinge seats. The unseating caused flexural failures of the box girder. An apparent cause was the large torsional response associated with skewed geometries.

Fig. 22 I-5 Gavin Canyon undercrossing (<http://ntl.bts.gov>)
