Lessons in bridge damage learned from the Wenchuan earthquake

Abstract: A strong earthquake occurred in Wenchuan County, Sichuan Province, China, on May 12, 2008. Shortly after the earthquake, the Turner-Fairbank Highway Research Center of the Federal Highway Administration, in partnership with the Research Institute of Highways, the Ministry of Communication of China, led a reconnaissance team to conduct a post-earthquake bridge performance investigation of the transportation system in the earthquake affected areas. The U.S. transportation system reconnaissance team visited the area during July 20–24, 2008. This paper presents the findings and lessons learned by the team.

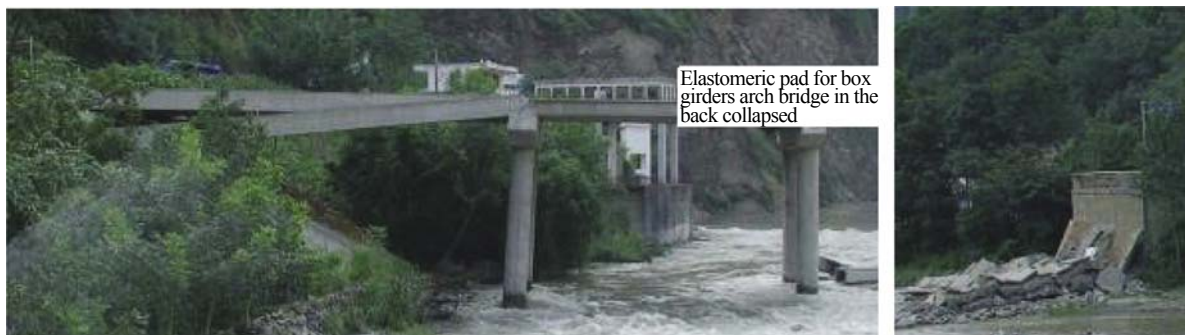
Three bridges crossed near Nanba Town as shown in Fig. 2. The west structure was a concrete and masonry three-span arch bridge built in the 1970 s. The old arch bridge completely collapsed during the earthquake as shown in Fig. 3. Immediately downstream of the arch bridge was a 10-span river crossing (on a 10° skew) that was under construction during the earthquake, as shown in Fig. 4. Each 6 m long span was simply supported on two-column bents and seat-type abutments with 560 mm seats. As shown in Fig. 5, each span consisted of eight precast box girders with a cross section of 1067 mm by 1520 mm. Each girder was supported on two 200 mm round elastomeric bearings at each end. The girders were in place but the concrete deck had not yet been poured at the time of the earthquake, as seen from Fig. 5.

Fig. 3 Collapse of the old three-arch bridge

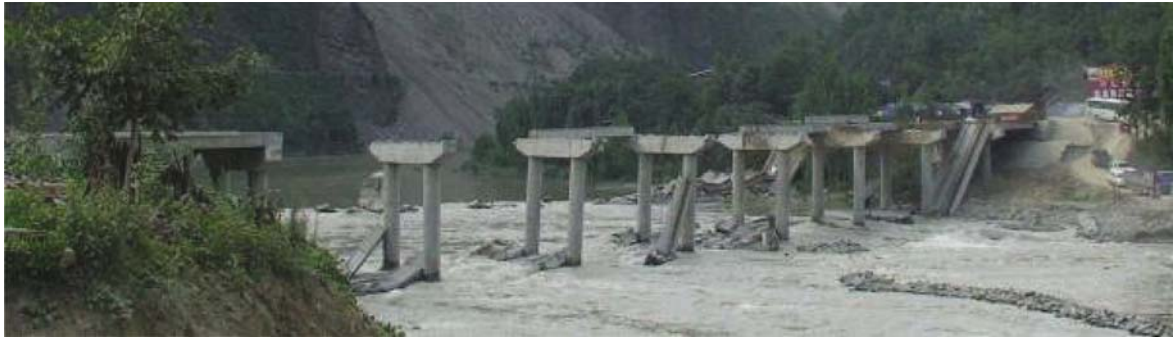
As shown in Figs. 4 and 5, most of the box girders of the new bridge dropped into the river and the two-column bents were distorted. The end box girders were transversely displaced by approximately 760 mm. The deck had not yet been poured, there was no transverse

Fig. 4 Damage scenario of the 10-span bridge under construction during the earthquake

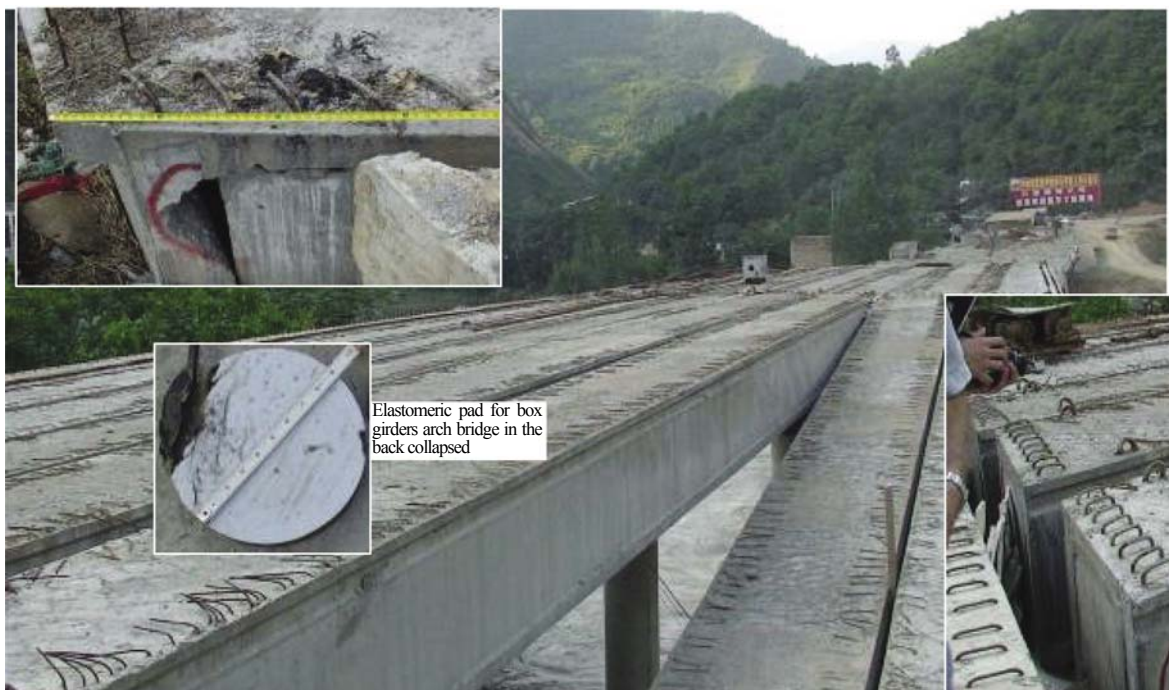
Fig. 5 Damage to the 10-span bridge under construction

bracing or shear keys, and girders were on a slight skew, all of which contributed to the damage. Also, many of the bents were leaning or distorted, but no damage was visible above the waterline.

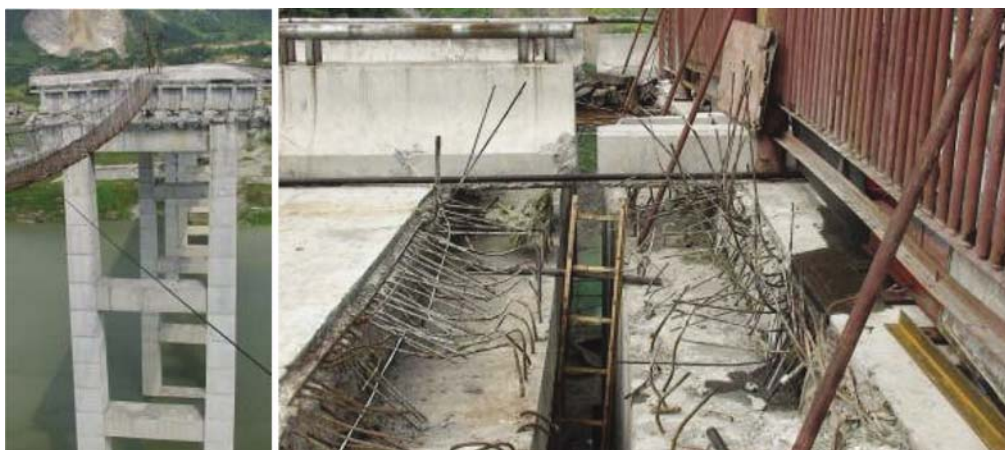
The construction of the bridge was near completion except for the installation of expansion joints at the time of the earthquake. The most severe damage was to the end span of a five-span T-girder segment that became unseated at the expansion joint end, fractured in the continuous deck at the other end due to gravity load, and fell off the supporting bent caps during the earthquake. The bent seats were approximately 300 mm in length but the bridge experienced at least 500 mm of

Fig. 10 Drop-off span and construction details between two spans

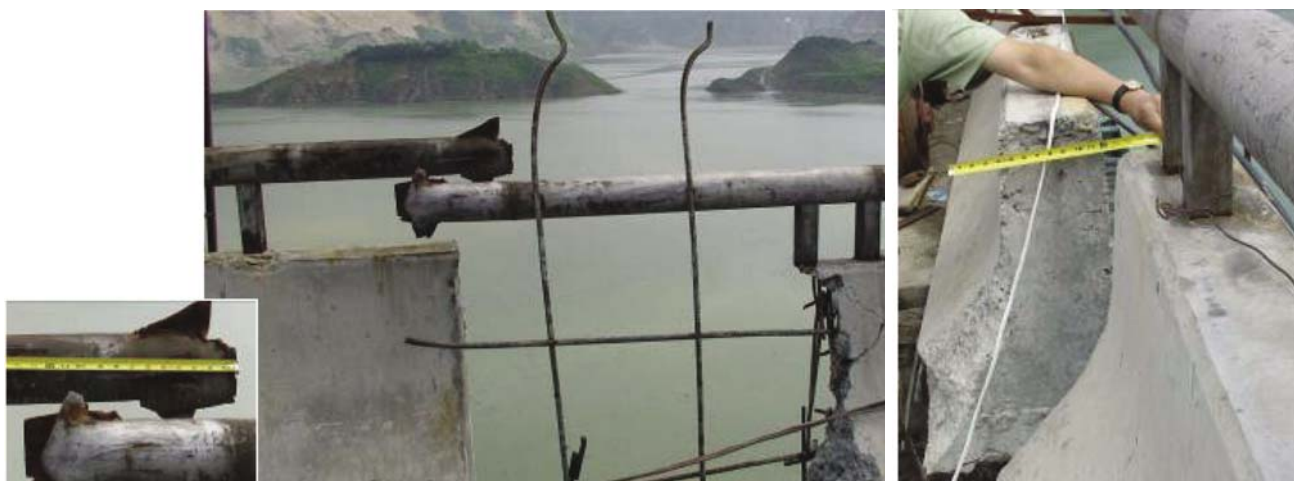
longitudinal movement due to earthquake shaking. Since the columns of each bent are approximately 105 m tall, the accumulated displacement at the bent cap was likely significant during the earthquake. There were other indications of large longitudinal movement. In Fig.11, the barrier rails were overlapped by about 300 mm at the southeast expansion joint. The barrier also displaced transversely for approximately 250 mm. Divers found cracks at the bottom of the main span columns due to earthquake shaking. Shear key failure was also observed as shown in Fig. 12. After the earthquake, the bridge deck was jacked back into place with hydraulic jacks.

Fig. 11 Longitudinal and transverse offset of bridge deck

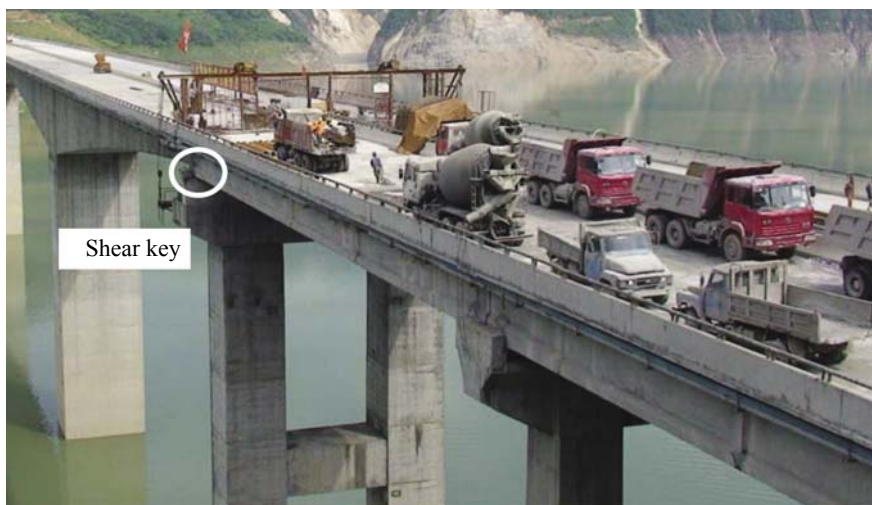
Fig. 12 Shear key failure

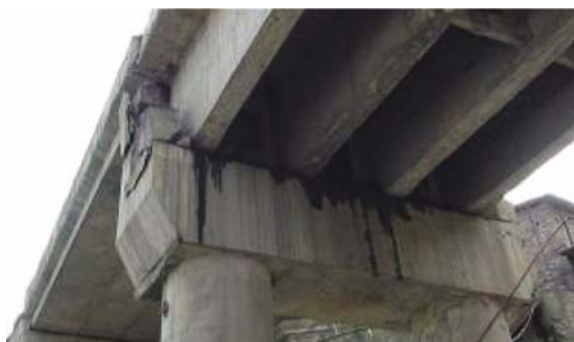
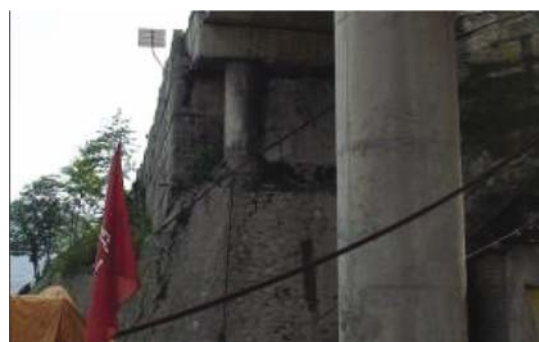
The end of the Miaoziping Bridge near the tunnel is divided into two parallel elevated structures in order to guide two lanes of traffic to be in alignment with the twin tunnels as indicated in Fig. 13. Over the southeast approach is a four-span RC girder bridge built in 2004. The bridge supports the old highway from Dujiangyan to Wenchuan and Jiuzhaigou. The old highway was built along the mountain terrain, perpendicular to the Miaoziping Bridge at Zipingpu Reservoir. The bridge showed shear key failures and embankment cracking as shown in Fig. 14.

Fig. 14 Damage to shear key (left) and embankment of the overpass (right)

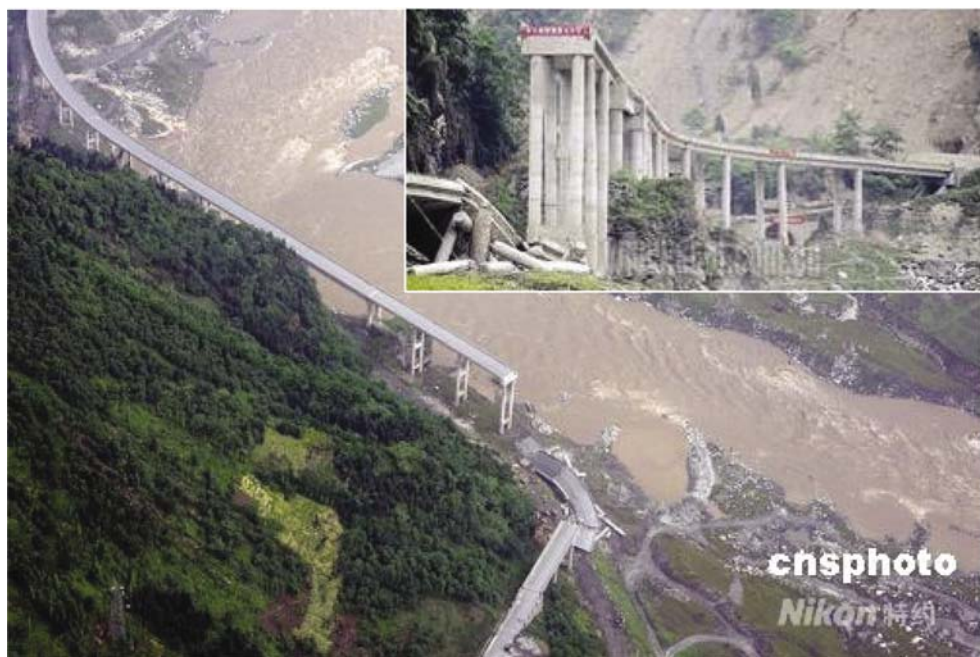
During the earthquake, the more highly curved section of the bridge completely collapsed as illustrated in Fig. 17. The rest of the bridge suffered varying degrees of damage, including shear cracks and failure at columns and struts, shear key failure, and bearing failure as shown in Figs. 18–21 for Bents 3, 9, 15, and 18, respectively. At

At the curved part of the bridge, the bridge is likely subjected to higher deformation and stress under the earthquake, resulting in collapse. Even on the straight part of the bridge, due to tall columns, the damage in various sections resulted in tilting of the columns that pushed the superstructure almost off their support at several locations. A detour had been graded along the side of the damaged bridge. Considering the high risk of further collapse during an aftershock that could endanger people using the detour, the rest of the bridge was demolished with dynamite as illustrated in Fig. 22.

Fig. 17 Post-earthquake damage

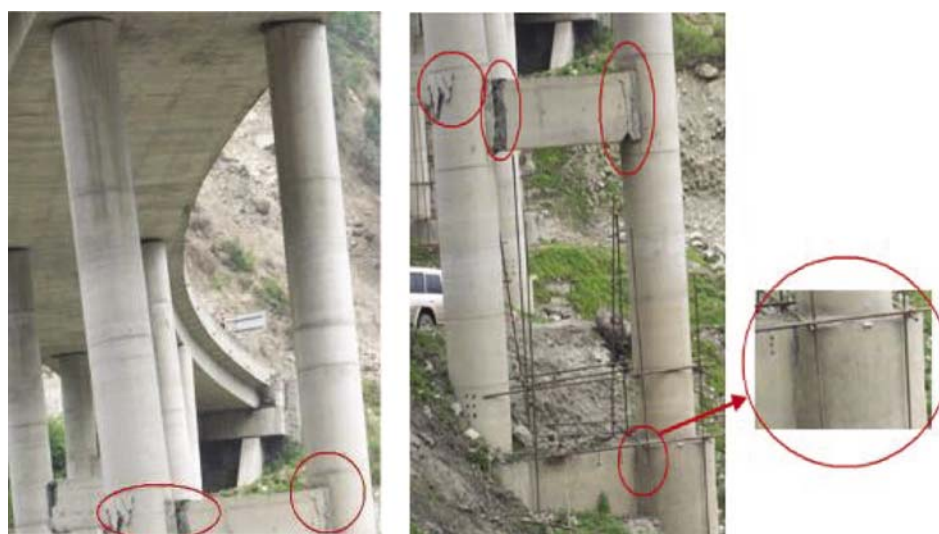
Bent 3, typical damage occurred between the strut and columns in the form of spalling and cracks. At Bent 9 with expansion joints, the superstructure had significant transverse displacement, knocking off the shear key. At Bent 15, the bridge section was completely collapsed most likely due to the shear and flexural failure of the columns. At Bent 18, in addition to cracks between the column and strut, significant spalling occurred underneath the bridge deck.

Fig. 18 Damage at Bent 3

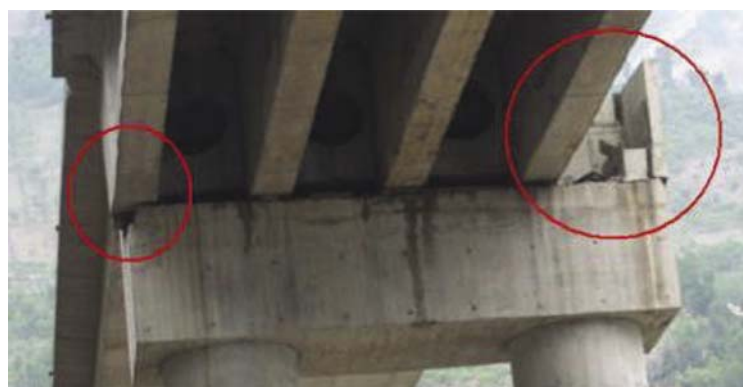
Fig. 19 Damage at Bent 9

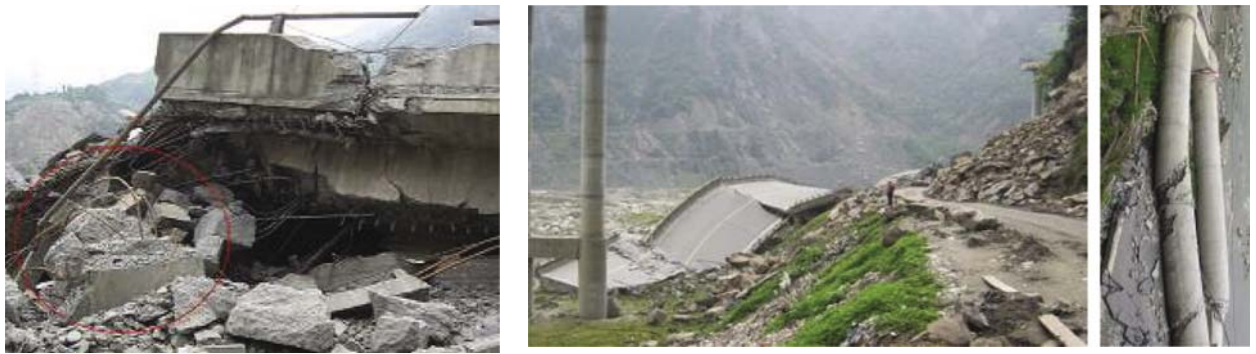
(a) Column shear and flexural failure

(b) Column shear failure and Section 5 collapse

Fig. 20 Damage at Bent 15

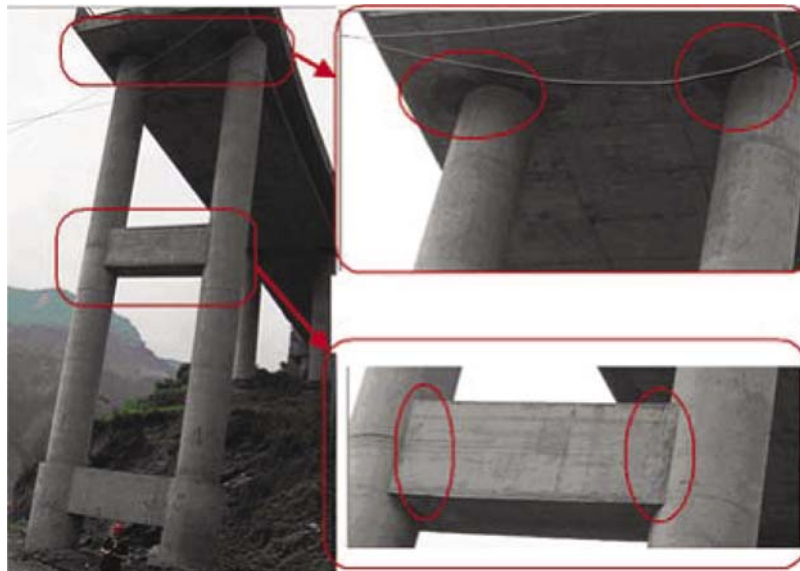
Fig. 21 Damage at Bent 18

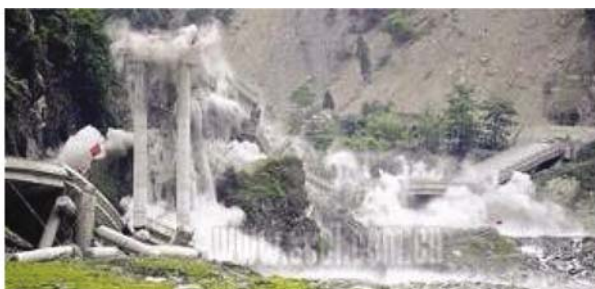
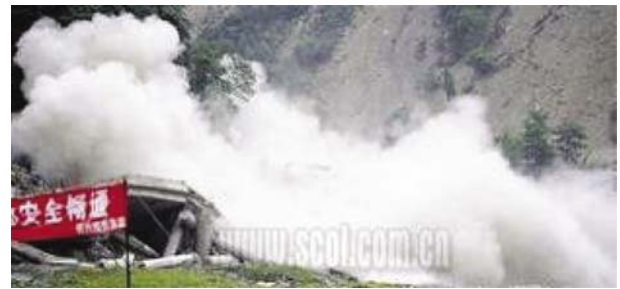
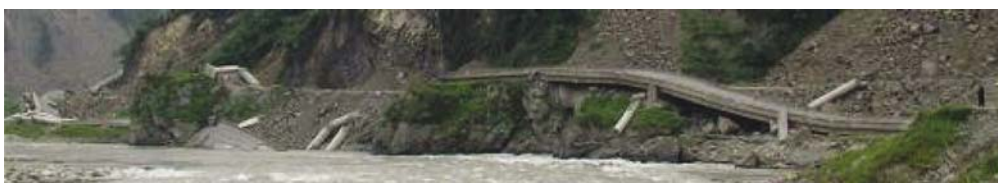
Fig. 22 Post-earthquake demolition of Baihua Bridge
