Liquefaction macrophenomena in the great Wenchuan earthquake

Abstract: On May 12, 2008 at 14:28, a catastrophic magnitude M_s 8.0 earthquake struck the Sichuan Province of China. The epicenter was located at Wenchuan (31.00°N, 103.40°E). Liquefaction macrophenomena and corresponding destruction was observed throughout a vast area of 500 km long and 200 km wide following the earthquake. This paper illustrates the geographic distribution of the liquefaction and the relationship between liquefaction behavior and seismic intensity, and summarizes the liquefaction macrophenomena, including sandboils and waterspouts, ground subsidence, ground fissures etc., and relevant liquefaction features. A brief summary of the structural damage caused by liquefaction is presented and discussed. Based on comparisons with liquefaction phenomena observed in the 1976 Tangshan and 1975 Haicheng earthquakes, preliminary analyses were performed, which revealed some new features of liquefaction behavior and associated issues arising from this event. The site investigation indicated that the spatial non-uniformity of liquefaction distribution was obvious and most of the liquefied sites were located in regio

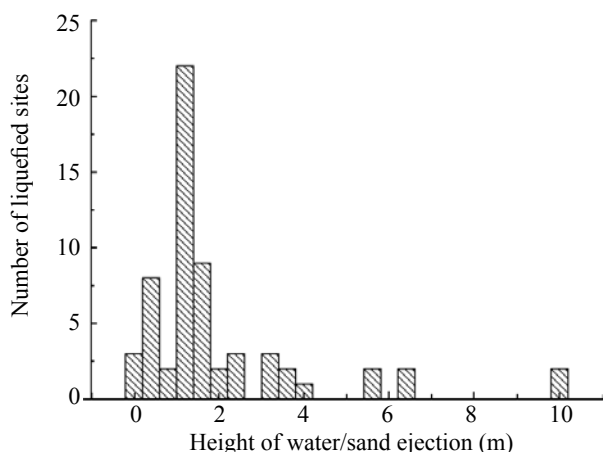
amount of water/sand ejection can reflect the depth and thickness of the liquefied soil layer. Figure 2 statistically presents the number of liquefied sites versus the height of water/sand ejections. Obviously, the heights at most liquefied sites are within 1 m to 3 m. However, there are four sites with water ejection height of more than 6 m. These sites are located in Chengdu, Mianyang, Ya'an and Deyang areas, respectively, with the closest distance between two adjacent liquefied sites at more than 30 km. Using the liquefied site in Xiangliu Village of Mianzhou City as an example, the water ejection had a height of about 15 m, or double the height of the electric pole (Fig. 3). Such phenomena of high water/sand ejection have seldom been observed in previous earthquakes. Preliminary analysis indicates that they may have been caused by deep soil liquefaction.

Fig. 2 Statistics of the height of water/sand ejection versus the number of liquefied sites

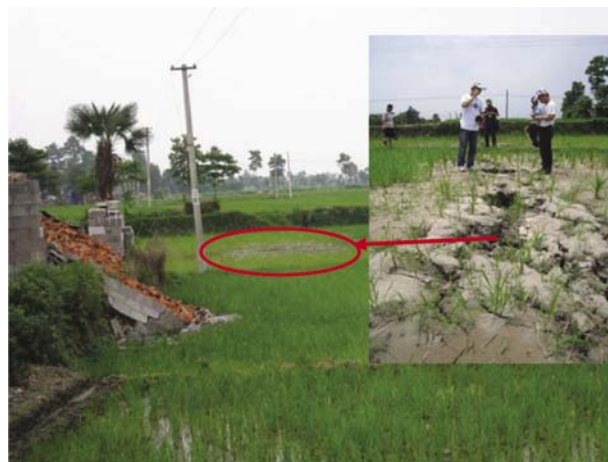
Fig. 3 Liquefied site with a high water ejection of about double the height of the wire pole and a visible ground failure (Photo by WM Wang)

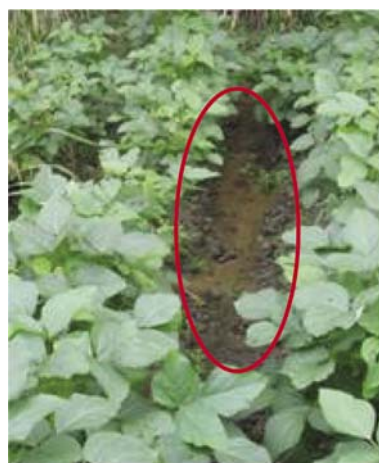
Fig. 4 Yellow ejected sand and water in Xinlian Village of Leshan City, where water spouting lasted more than 3 months (Photo by LW Chen)

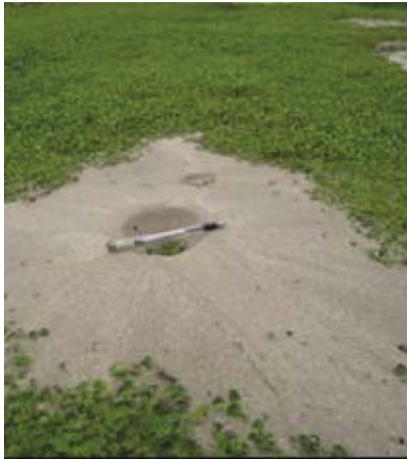
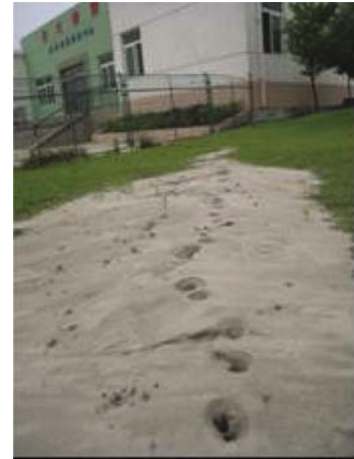
Figure 5 shows sand boils and aligned sand boils following the earthquake. Compared with previous

Fig. 5 Large sand boil (left) and aligned sand boils along the crack in the ground (right) in Mianyang area (Photo by ZZ Cao)

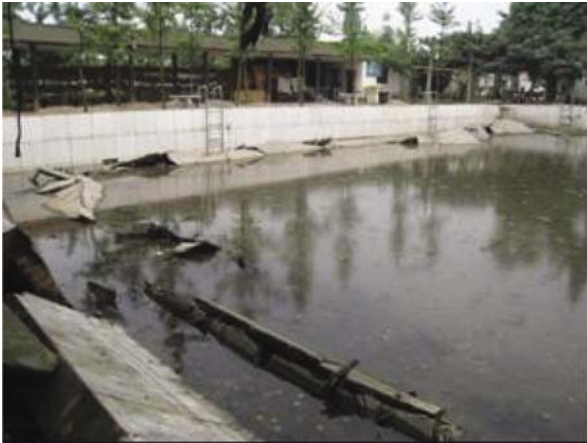
cases (Hu, 1988; Liao, 1989; IEM, 1979; Liu *et al.*, 2002), the sand amount ejected in this event was generally not remarkable. The site investigation shows that a thick pure sand layer can hardly be detected, but loose gravelly sandy soil layers exist universally. In the 1976 Tangshan earthquake, for example, the sand that was ejected was buried in a vast area of farmland, since the local soil in the Tangshan area contains thick pure sandy layers. However, there are also some typical sites with a relatively large amount of sand ejection. In Siyuan Village of Shifang City, for example, an initially empty swimming pool of 50 m × 20 m × 2 m was filled with ejected sand and water 1 m deep after the earthquake (Fig. 6). Moreover, a crack of about 50 m long occurred on the ground close to the swimming pool. Sand also ejected from the crack during the earthquake.

Fig. 6 Previously empty swimming pool filled with ejected sand and water of about 1m in depth after the earthquake (Photo by ZZ Cao)

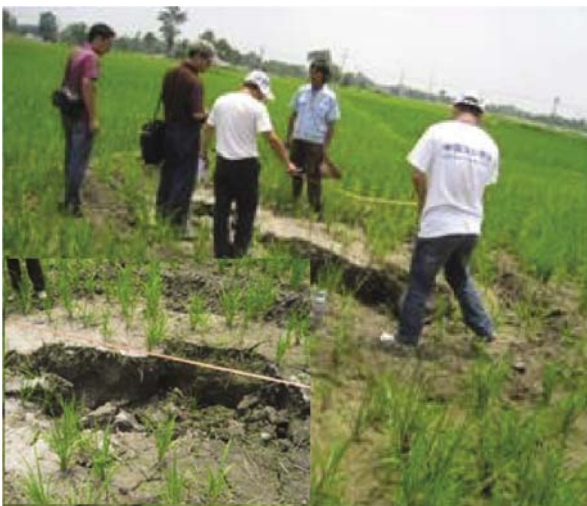
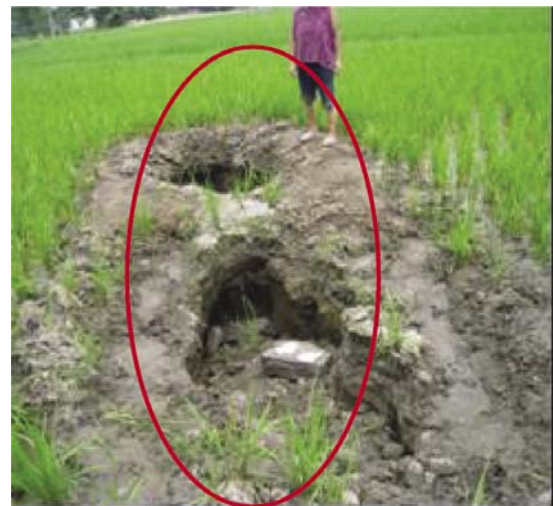
The ground usually subsides following sandboils and waterspouts caused by liquefaction. During the post-earthquake in-situ investigation, typical ground subsidence was observed in ten villages. For example, in Xiangliu Village of Mianzhu City, eight pits of 3 m to 4 m in diameter and 1 m to 2 m in depth were found throughout the farmland areas (Fig. 7). In the Caidikan Village of Meishan City on the 14th of May (i.e., the third day after the main shock), water spouting suddenly started and lasted about one minute. Subsequently, a large pit of 2 m in diameter and 2 m deep appeared (Fig.8). Pits or ground subsidence created by liquefaction can result in severe destruction to adjacent structures. Figure 9 illustrates a large pit created by liquefaction that destroyed an adjacent house.

Fig. 7 Large pits of about 3 to 5m in diameter (left) and ground failure (right) were created by water/sand ejection in Xiangliu Village (Photo by WM Wang)

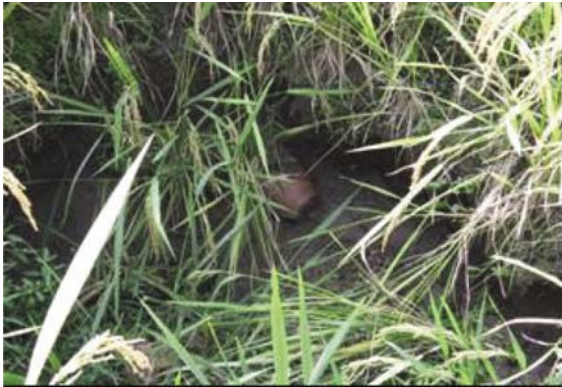
Fig. 8 Pit of 2 m in diameter caused by water spouting in Caidikan Village (Photo by ZZ Cao)

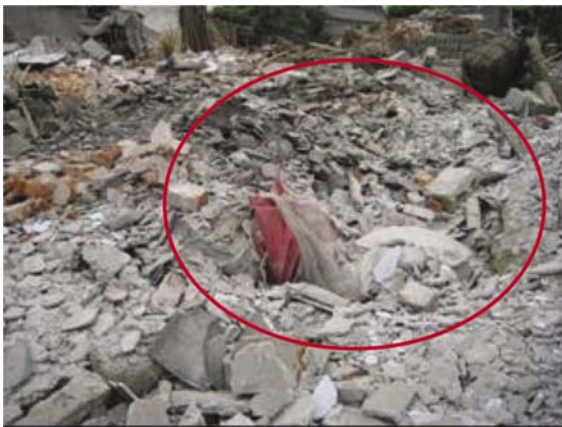
Fig. 9 Large pit of about 3 m in diameter destroyed a house (Photo by ZZ Cao)

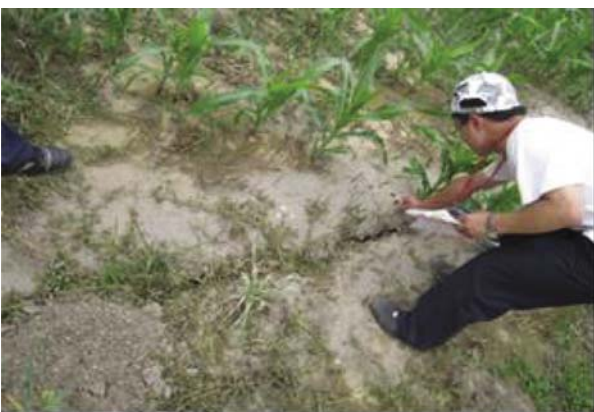
(a) Ground fissure and sand ejected

Ground fissures were observed at 70% to 80% of the liquefied sites with various lengths from tens to thousands of meters (Fig. 10). In Fig. 10 (a), sand was

Fig. 10 Ground fissures caused by liquefaction and the sand ejected during the earthquake (Photo by LW Chen)

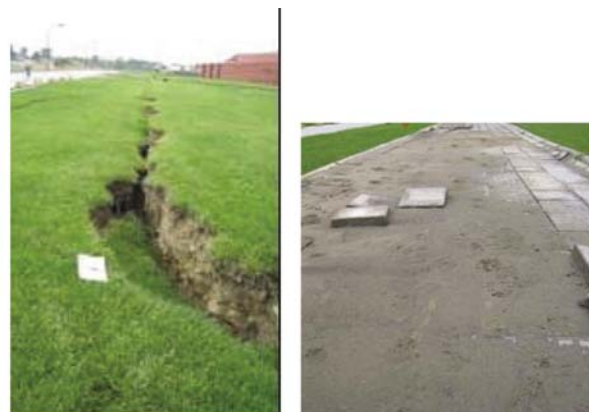
(b) Ground fissure and visible sand ejected

ejected from the ground fissure created by liquefaction. Figure 10 (b) shows similar examples in Dujiangyan City, where a ground fissure of about 30 m long and a maximum width of 0.5 m was created just adjacent to the sand ejection point (Fig. 10 (b), left). Ground fissures can be dangerous to structures or aggravate structural damage, e.g., tilt and settlement of buildings, etc. Alternatively, liquefaction may have a positive shock absorption effect on structural damage as observed after the Tangshan and Haicheng earthquakes (Hu, 1988; IEM, 1979; Liu *et al.*, 2002). However, this phenomena was not detected in this investigation.

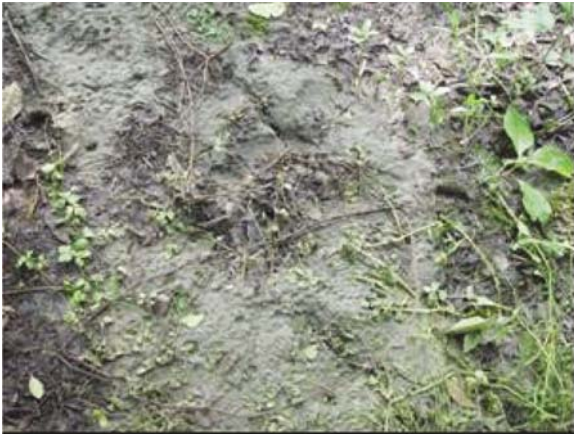
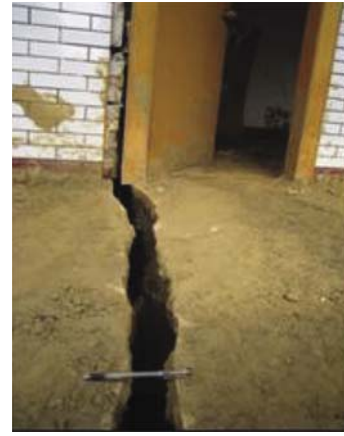
Generally, 50% to 60% of the ejected materials are silty sand and fine sand (Fig. 11). For example, in Xinglong Village of Banqiao Town, the yellow fine sand ejected from a ground crack generated by liquefaction. The crack penetrated a house and resulted in damage to both the house and its foundation (Fig. 11; left).

Fig. 11 Grey and yellow fine sand ejected to the ground following liquefaction behaviors (Photo by JS Bo and ZZ Cao)

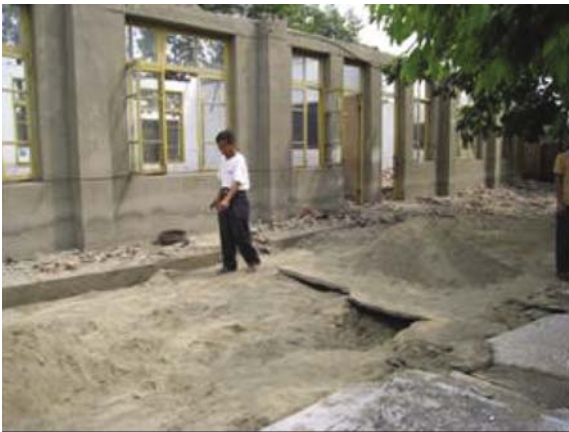
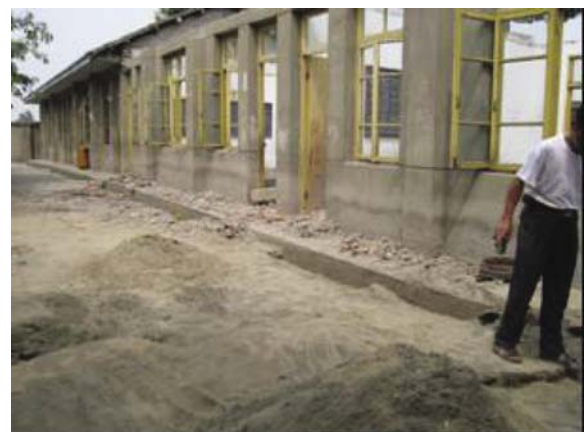
course sand (Fig. 12). Figure 12 is an example from Bilu Preliminary School. The classrooms of the one-story brick-concrete structures were jeopardized by liquefaction and torn down afterward.

Fig. 12 Medium sand was ejected to the ground in Bilu Preliminary School and caused the destruction of the classrooms (Photo by ZZ Cao)

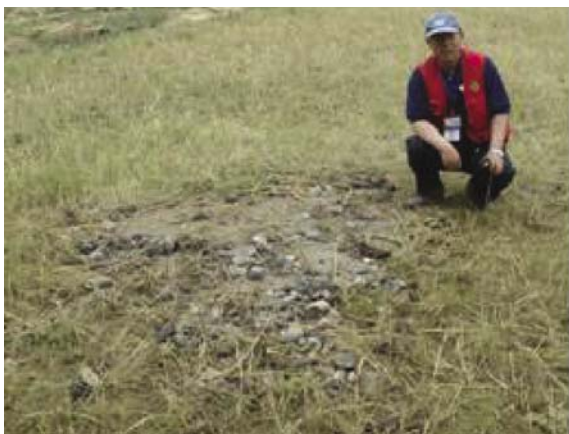
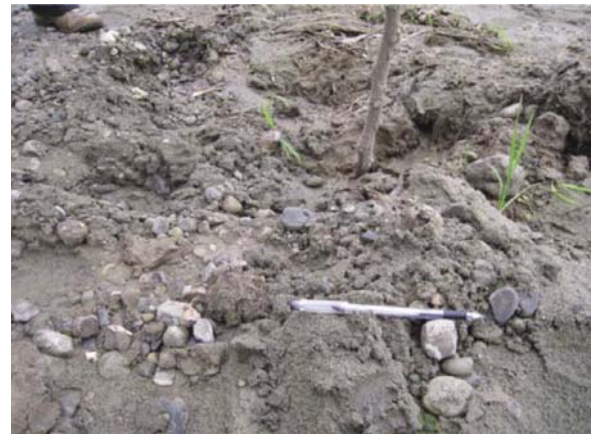
Fig. 13 Gravelly sand of 3 cm to 15 cm in diameter ejected to the ground (Photo by SY Li and ZZ Cao)

One typical observation of liquefaction is gravel ejected to the ground. Figure 13 shows evidence of this behavior, which was observed for the first time in China mainland. About ten sites with gravelly sand ejected were found during the post-earthquake investigation. The corresponding ejected material contained gravels an average of 3 cm to 15 cm in diameter. The phenomena indicate that even a site of gravel can liquefy. In previous earthquakes, for example of the 1994 Hokkaido-Nansei-Oki earthquake, the soil containing large cobbles of 20 cm to 30 cm in diameter had been liquefied. This behavior also occurred in the 1995 Kobe and 1999 Chi-Chi earthquakes. The susceptibility of gravelly soil needs to be evaluated properly for seismic resistant design with suitable and feasible methods.

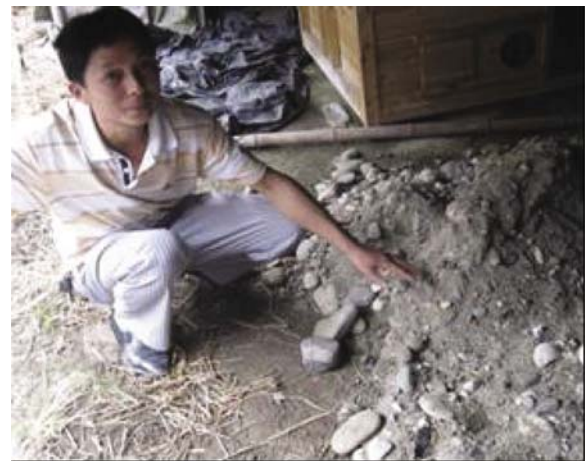
In Baihutou Village of Mianzhu City, a well of 3 m deep was filled with ejected material containing large-diameter gravels (Fig. 14) after the earthquake. The diameter of gravel varies from several centimeters to tens of centimeters. Figure 14 shows the material sampled from the well.

Fig. 14 Gravel sand sampled from the well in Baihutou Village of Mianzhu City (Photo by ZZ Cao)

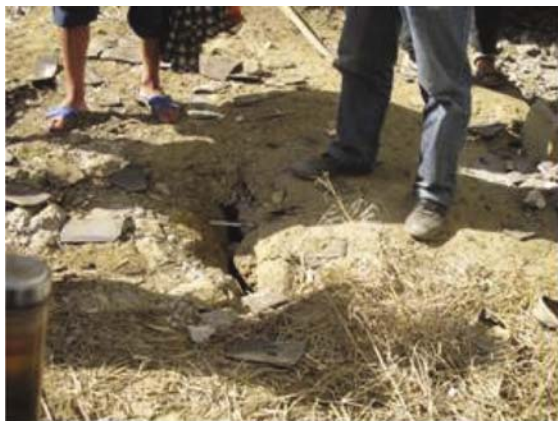
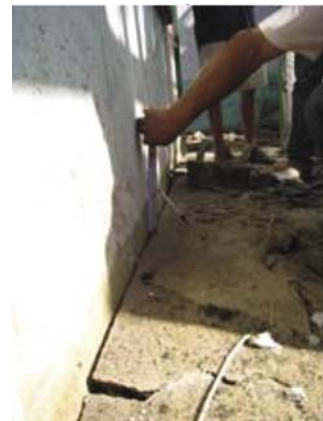
In Guoyuan Village of Deyang City located in a region of seismic intensity of VII, waterspouts and sandboils were observed on the day following the main shock. However, the same phenomenon re-occurred during an aftershock of magnitude $M_s 6.4$ (Fig. 15).

Fig. 15 Liquefaction reoccurrence following the aftershock (left) and subsidence of the house adjacent (right) (Photo by WM Wang)

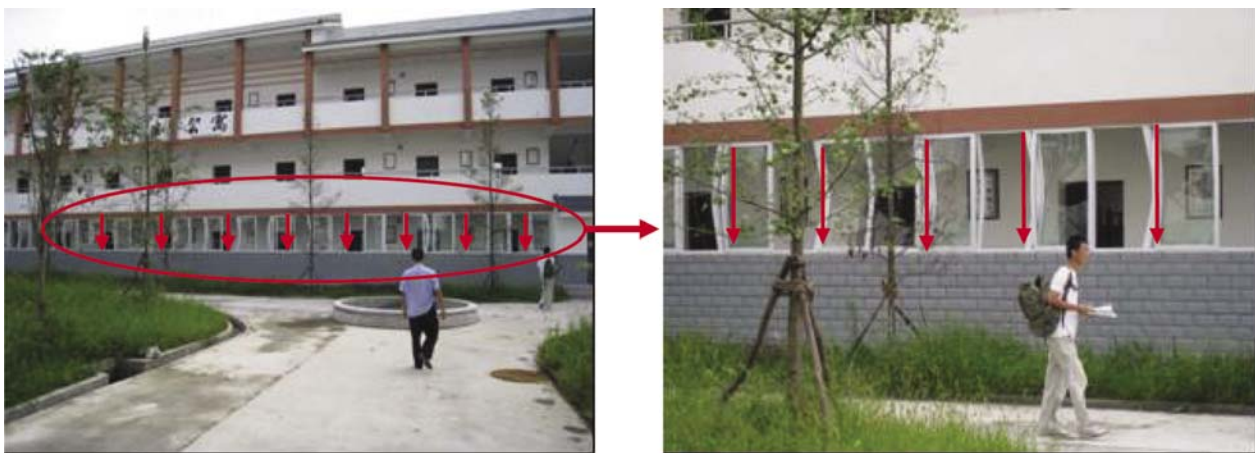
In the post-earthquake investigation, liquefaction-induced damage to structures and infrastructures observed included factories, roads, bridges, and farmlands, etc. Figures 16, 17 and 18 show some examples. In Fig. 16, for example, sand ejection and water spouting occurred around a teaching building of Zhongxing Middle School in Dujiangyan City. Consequently, the entire building subsided, resulting in deformation of the window

Fig 16 Liquefaction-induced settlement/differential settlement caused the deformation of the window frames in Zhongxing Middle School in Dujiangyan City (Photo by LW Chen)

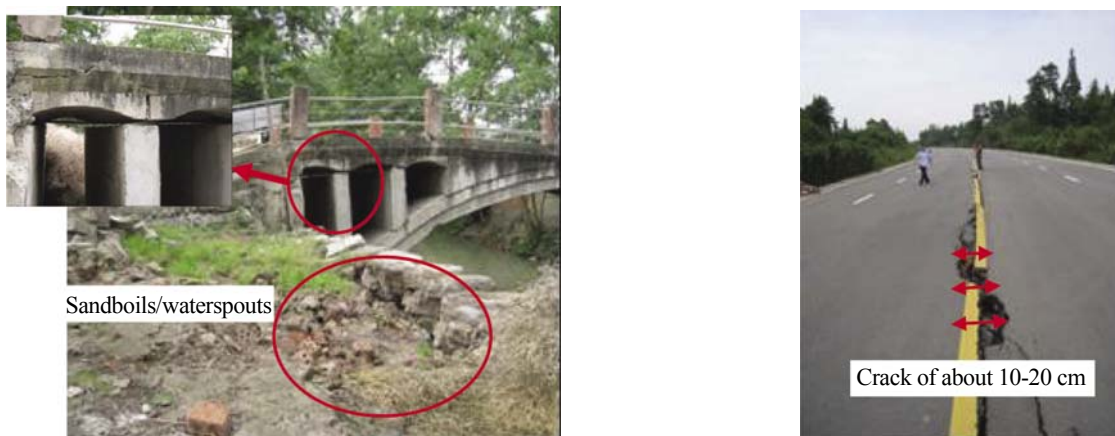
frames. In Fig. 17 (left), sandboils and waterspouts occurred close to a bridge and caused it to subside and become unusable. Severe liquefaction is shown in Fig. 17 (right), with the water ejection height of 1 m, and 10 cm to 16 cm lateral spreading at a country road in Dujiangyan City, resulting in road damage. At the liquefied sites, poorly constructed houses without any consideration of seismic resistant design collapsed, and confined masonry houses/buildings subsided or tilted. For example, at Banqiao School, the main teaching building that was almost intact was torn down due to the settlement and tilt of the structure and foundation caused by liquefaction (Fig. 19). Another typical example is the Jianyou Railway Station (Fig. 20). Apparently, the station was intact after the earthquake (Fig. 20 (a)). However, a detailed investigation found that its foundations subsided due to subsoil liquefaction (Fig. 20 (b)), and ejected sand was visible inside the station and caused ground cracks.

Fig. 17 Liquefaction-induced destruction to bridge (left) and road (right) (Photo by ZZ Cao and FC Meng)

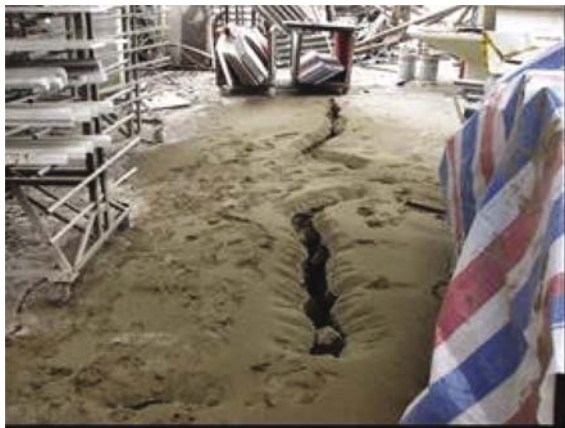
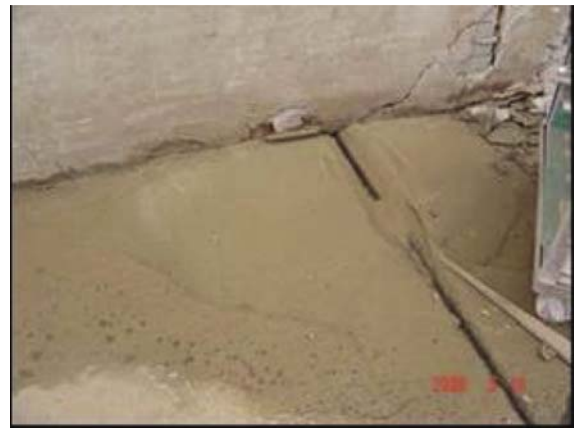
Fig. 18 Liquefaction- along with ground shaking, induced destruction to factories (Photo by ED Guo)

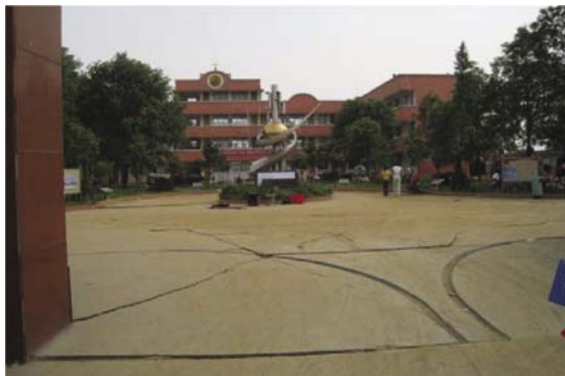
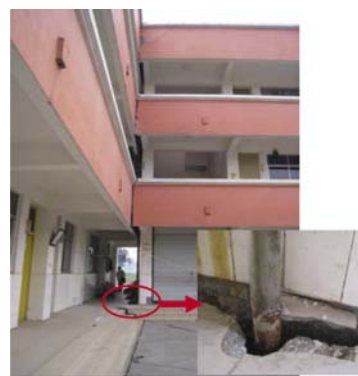
Fig. 19 Sand ejected in the school yard (left) and liquefaction-induced destruction/tilt of the main teaching building (right) of Banqiao School. (Photo by LW Chen)

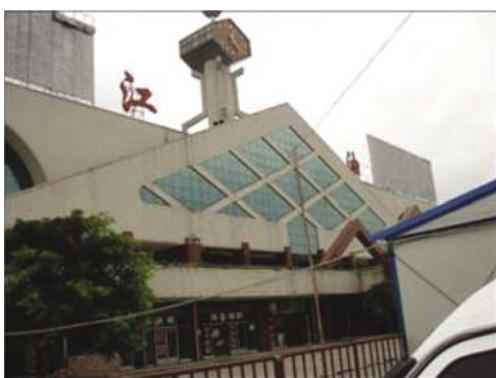
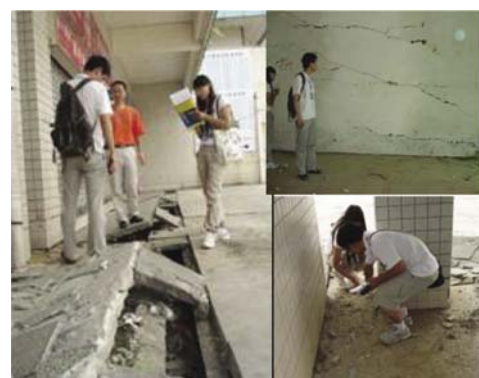
Fig. 20 Liquefaction-induced destruction of Jiangyou Railway Station along with ground shaking, including ground cracks and foundation settlement (Photo by WM Wang and L Dong)

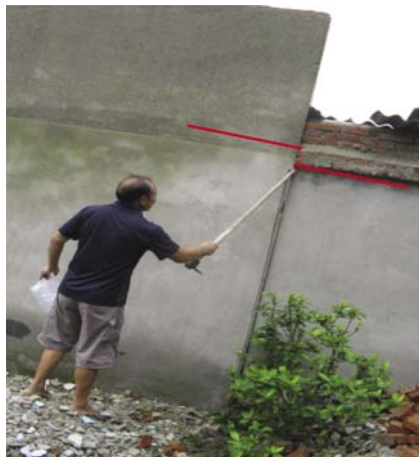
(a) Differential settlement caused by liquefaction

impact on structural damage. For example, in Baijiang Village of Deyang City, sandboils and waterspouts were observed at the base of a house (Fig. 21). The house, which was a 2-story brick structure, was seriously damaged and tilted with differential settlement (Fig. 21 (a)); its floor had been removed because of the severe

Fig. 21 Liquefaction-induced structural damage along with ground shaking in Baijing Village of Deyang City (Photo by L Dong)

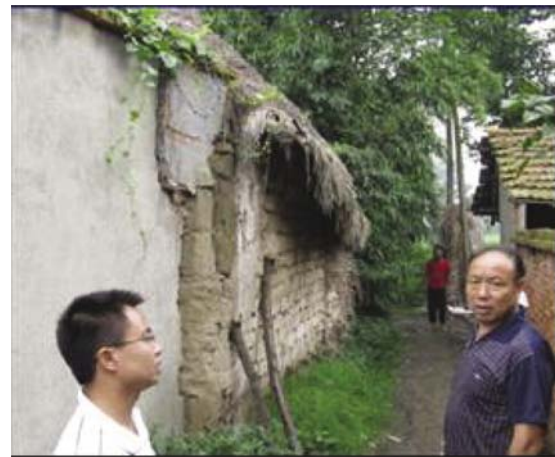
(b) Houses in the neighborhood of the house in (a) are almost intact

destruction. However, other houses in the neighborhood were almost intact (Fig. 21 (b)). Similar features were observed at some other liquefied sites during the field investigation. Note that most of the ground fissures generated by liquefaction were not uniformly distributed.
