Damage investigation of girder bridges under the Wenchuan earthquake and corresponding seismic design recommendations

Li Jianzhong[†], Peng Tianbo[‡] and Xu Yan^{!‡}

State Key Lab for Disaster Reduction in Civil Engineering, Tongji University, Shanghai 200092, China

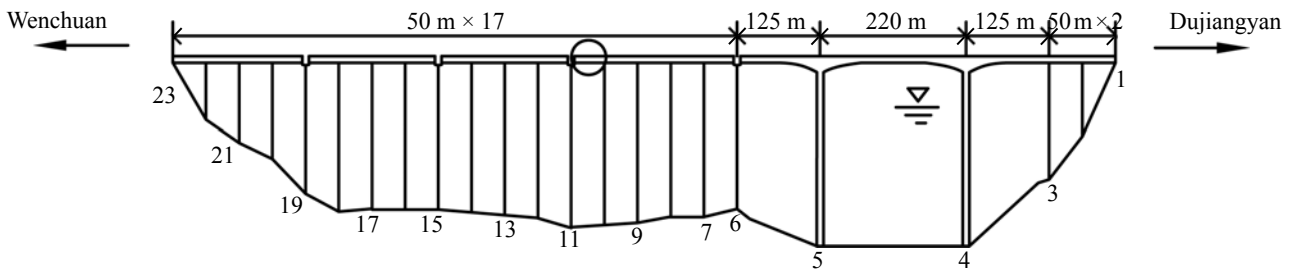
Fig. 2 Miaoziping Bridge

The Miaoziping Bridge is a long span-high pier bridge (see Fig. 2) near the Doujiangyan Ziping Dam, located 29 km from Yingxiu town, the epicenter of the Wenchuan earthquake. The main span consists of a continuous rigid frame 1.436 km long, with the highest pier over 108 m. The approach span consists of 50 m×19 spans simply supported girder with a continuous bridge deck. Each span was assembled with 10 pieces of T-shaped girder, weighing 140 t each. When the earthquake occurred, this bridge was not yet ready for traffic, as only the main structure had been completed. Due to the large relative displacement induced by the earthquake between the girder and the piers, the girder at the expansion joint of the fifth span of the approach bridge fell off, as shown in Fig. 3.

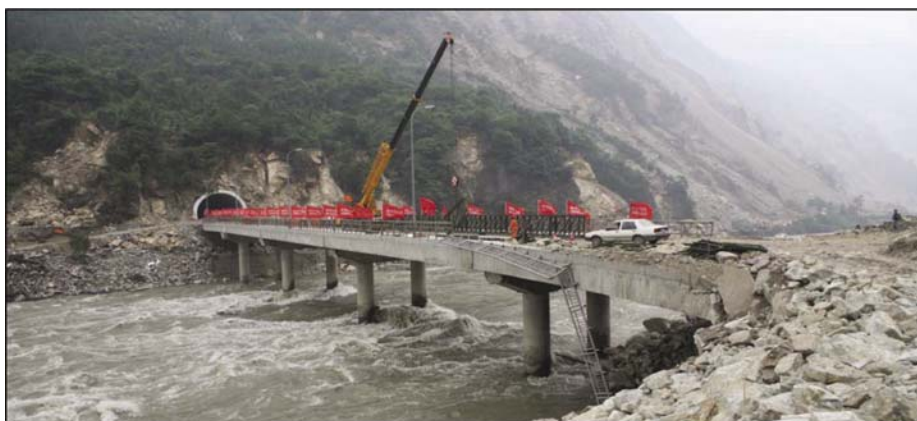
Fig. 9 Mingjiang Bridge in Yingxiu

continuous RC slab bridge as shown in Fig 9. The skew angle is 80° , which refers to the angle between the longitudinal continuous main slab and the lateral pier cap. During the earthquake, the slab on the Yingxiu side (left side of the figure) moved 0.8 m in the upstream direction, and the slab on the Wenchuan side moved about 2.0 m in the downstream direction. The slab moved totally off the bearings, and the shear key was also damaged (see Fig. 10).

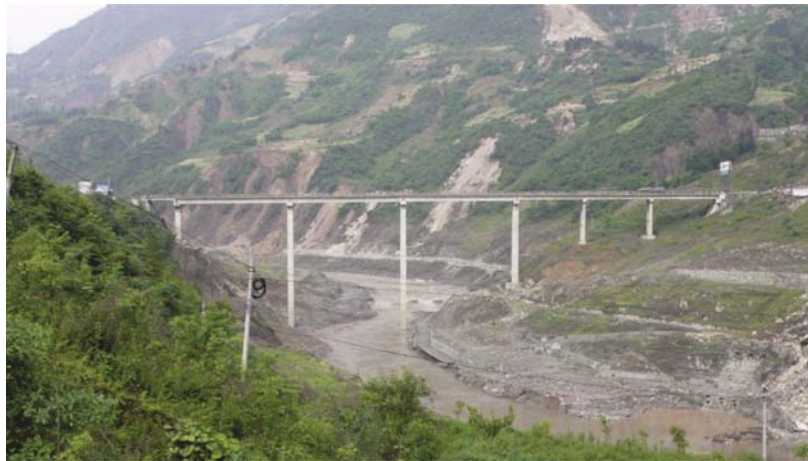
Fig. 11 Shoujiang Bridge

The Shoujiang Bridge, shown in Fig. 11, is a six span prestressed hollow slab bridge, with a span arrangement of $30\text{m} \times 3 + 50\text{m} \times 3 + 13\text{m}$, and is 263.3 m long.
