Revision of seismic design codes corresponding to building damages in the “5.12” Wenchuan earthquake

Wang Yayong[†]

Institute of Earthquake Engineering, China Academy of Building Research, Beijing 100013, China

Keywords: Wenchuan earthquake; earthquake damage to buildings; revision of seismic design codes

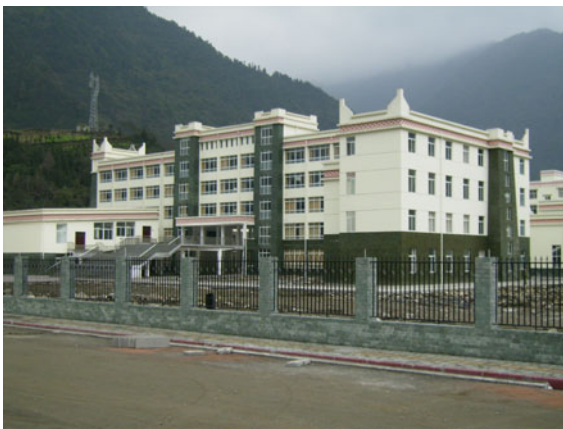
Figure 18 shows the Xuankou High School before the event in Yingxiu Town, Wenchuan County. The five-story teaching building and laboratory were constructed of two-bay RC frame structures with some redundancy. Fortunately, more than 1,200 students escaped from these two buildings, which survived the main shock with an intensity of over 11 degrees ($PGA \approx 1.0 g$) in the epicenter area. The teaching building partially collapsed and the laboratory totally collapsed in the aftershock (see Figs. 19–21).

Fig. 18 Xuankou High School constructed in 2006
