Lessons in bridge damage learned from the Wenchuan earthquake

Abstract: A strong earthquake occurred in Wenchuan County, Sichuan Province, China, on May 12, 2008. Shortly after the earthquake, the Turner-Fairbank Highway Research Center of the Federal Highway Administration, in partnership with the Research Institute of Highways, the Ministry of Communication of China, led a reconnaissance team to conduct a post-earthquake bridge performance investigation of the transportation system in the earthquake affected areas. The U.S. transportation system reconnaissance team visited the area during July 20–24, 2008. This paper presents the findings and lessons learned by the team.

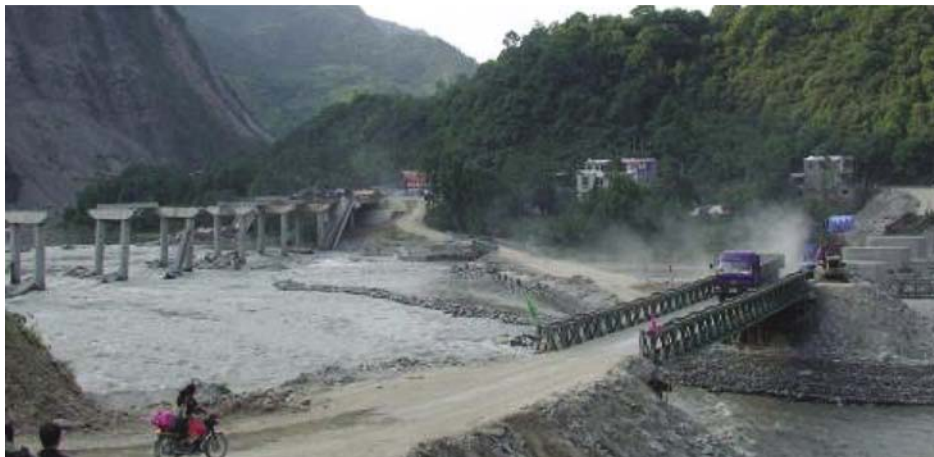
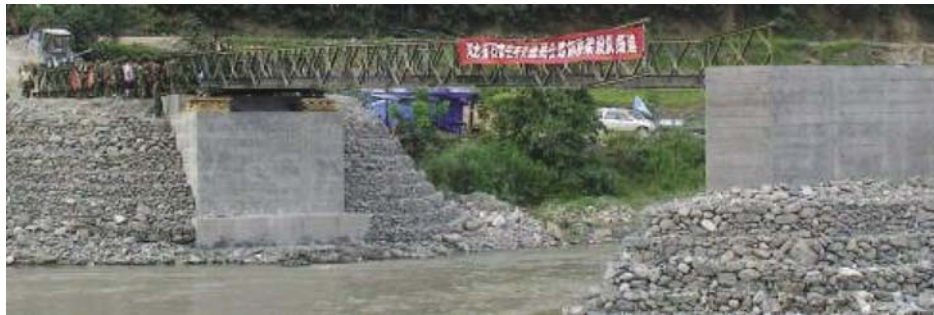
Fig. 6 Construction of a temporary bridge

On the east side of the old and new bridges is a temporary structure that was being constructed by launching Bailey Bridges onto new RC pier walls at the time of field reconnaissance. As shown in Fig. 6, vehicles were driving across the river on fill material

(a) Overview of a temporary bridge construction

(b) Bailey bridge pushed in place

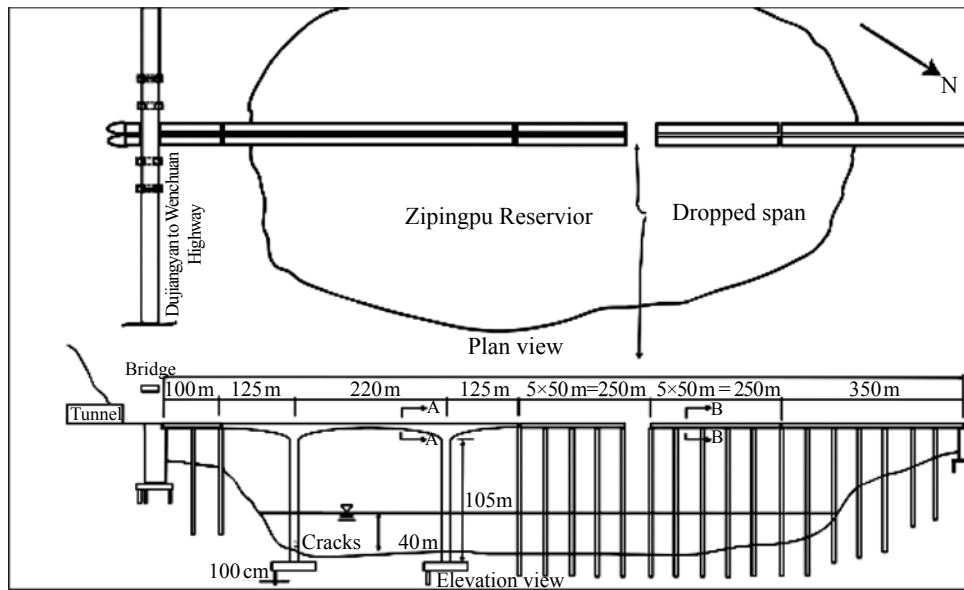
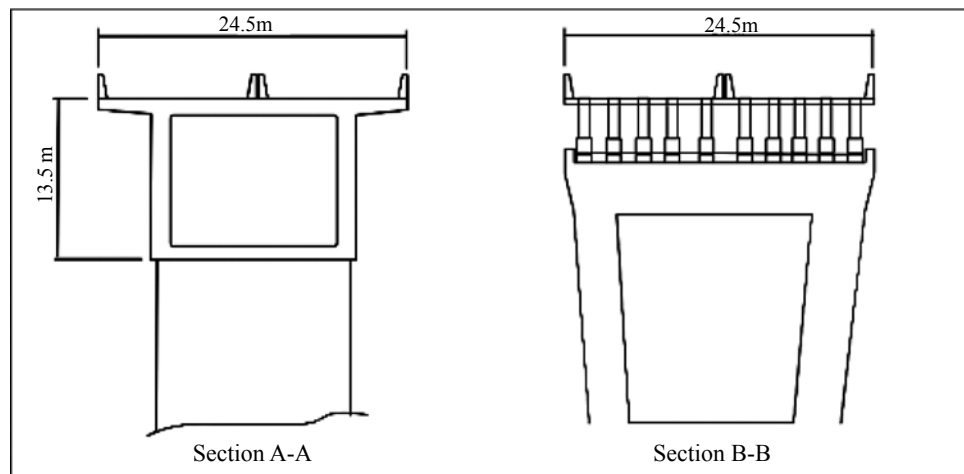
Fig. 7 Schematic view of the Miaoziping Bridge

but the girders are simply supported on the bents. From Figs. 7 (a) and 7 (b), the main bridge is a continuous, non-prismatic, three-span structure supported on two intermediate wall piers with 125 m, 220 m, and 125 m length, respectively. The superstructure is a single-cell box girder structure. The depth of the girders varies to a maximum depth of 4.0 – 4.5 m.

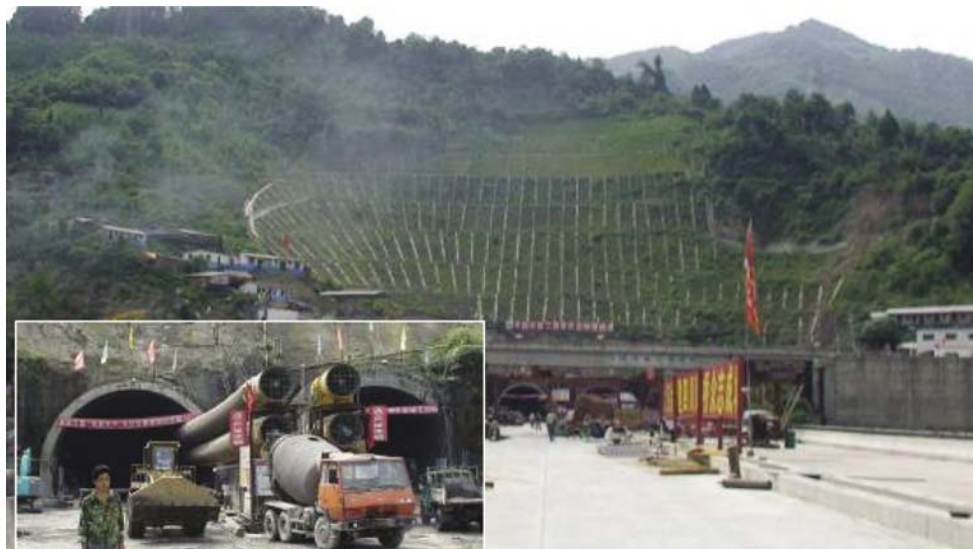
Fig. 8 Miaoziping Tunnel

Miaoziping Bridge from Dujiangyan to Wenchuan was under construction during the earthquake. It consists of a tunnel at Zipingpu and a bridge over the Mingjiang River as schematically shown in Fig. 7. The tunnel is shown in Fig. 8 and experienced little damage during the earthquake. The bridge was scheduled to open in October, 2008. Near the bridge is the well-known Zipingpu Dam. The bridge of approximately 1.4 km long consists of three parts: a main span and two approach spans as shown in Fig. 9.

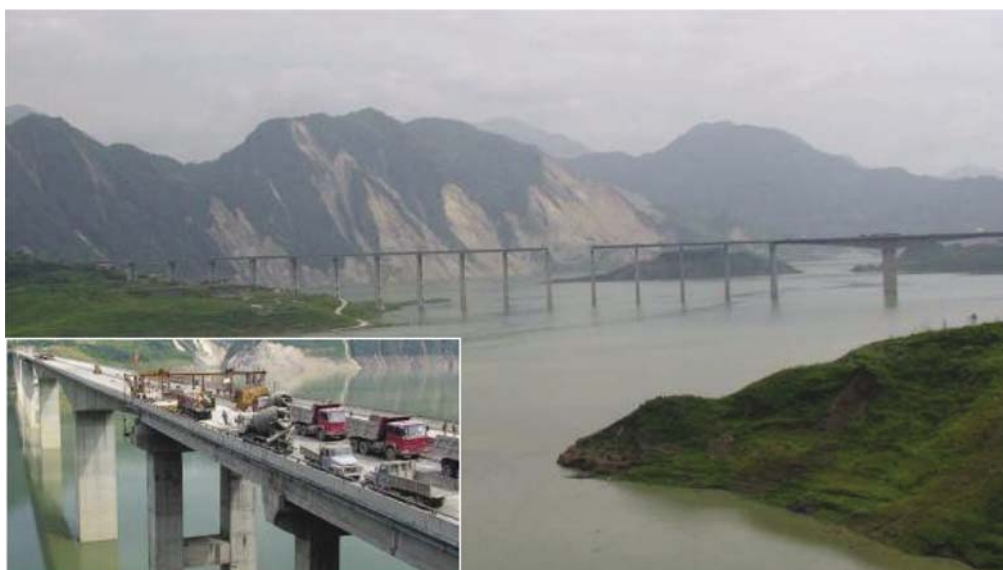
Fig. 9 Overview of the Miaoziping Bridge

The construction of the bridge was near completion except for the installation of expansion joints at the time of the earthquake. The most severe damage was to the end span of a five-span T-girder segment that became unseated at the expansion joint end, fractured in the continuous deck at the other end due to gravity load, and fell off the supporting bent caps during the earthquake. The bent seats were approximately 300 mm in length but the bridge experienced at least 500 mm of

longitudinal movement due to earthquake shaking. Since the columns of each bent are approximately 105 m tall, the accumulated displacement at the bent cap was likely significant during the earthquake. There were other indications of large longitudinal movement. In Fig.11, the barrier rails were overlapped by about 300 mm at the southeast expansion joint. The barrier also displaced transversely for approximately 250 mm. Divers found cracks at the bottom of the main span columns due to earthquake shaking. Shear key failure was also observed as shown in Fig. 12. After the earthquake, the bridge deck was jacked back into place with hydraulic jacks.

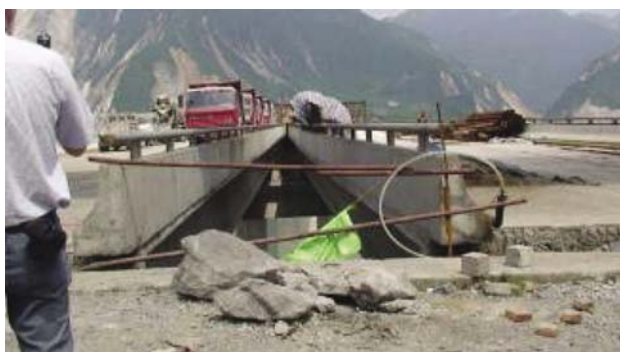
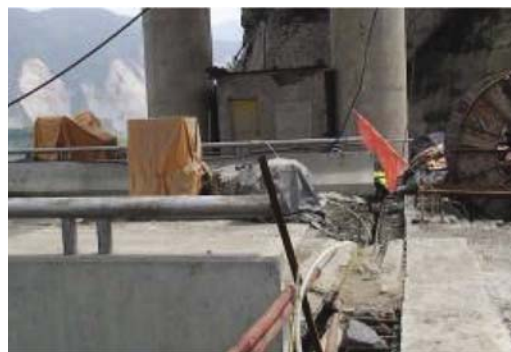
Fig. 13 End of the Miaoziping Bridge (left) and its overpass for the old highway (right)

The end of the Miaoziping Bridge near the tunnel is divided into two parallel elevated structures in order to guide two lanes of traffic to be in alignment with the twin tunnels as indicated in Fig. 13. Over the southeast approach is a four-span RC girder bridge built in 2004. The bridge supports the old highway from Dujiangyan to Wenchuan and Jiuzhaigou. The old highway was built along the mountain terrain, perpendicular to the Miaoziping Bridge at Zipingpu Reservoir. The bridge showed shear key failures and embankment cracking as shown in Fig. 14.

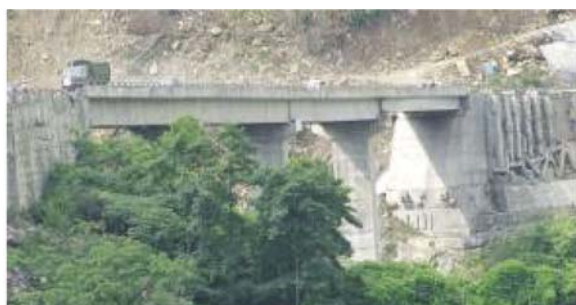
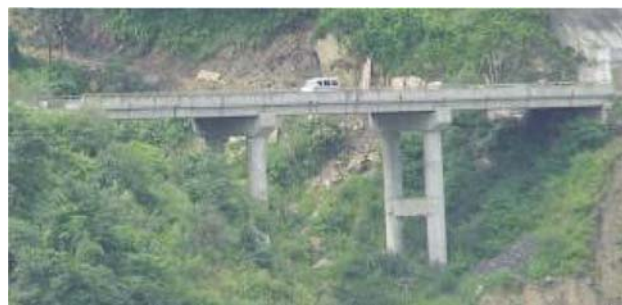
Fig. 15 Bridges in the vicinity of Miaoziping Bridge

In the vicinity of the Miaoziping Bridge, there are several RC girder bridges as shown in Fig. 15. These bridges appeared to suffer little damage. No weight limits were posted on these bridges.

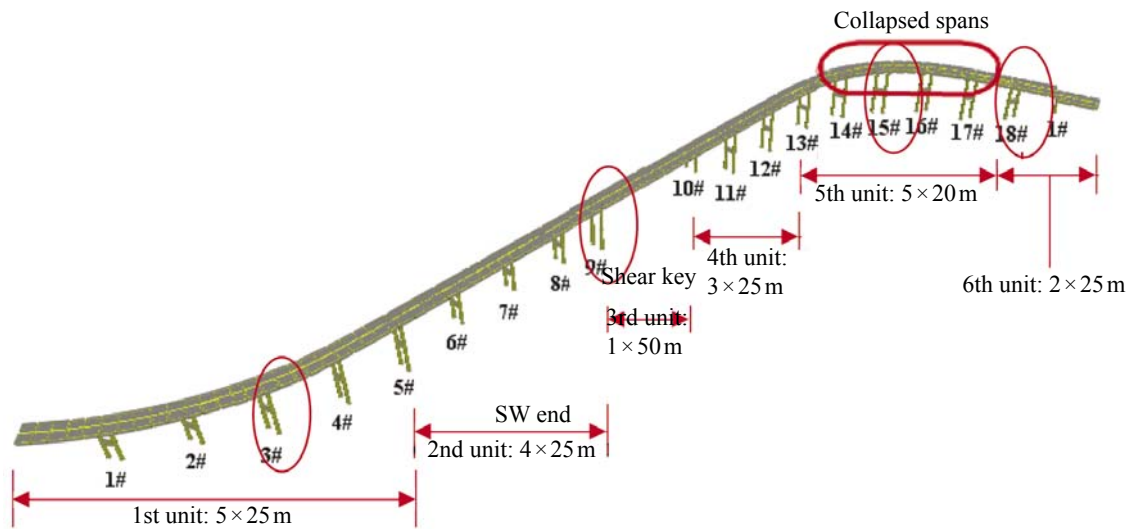
Fig. 16 Schematic view of the Baihua Bridge before the earthquake

The Baihua Bridge is part of a Class 2 Highway from Dujiangyan to Wenchuan. It was built in 2004 by the owner of a nearby hydroelectric plant to bring in workers. As schematically shown in Fig. 16, the bridge is an 18-span, RC structure with a total length of 450 m. The bridge superstructure was supported on two-column bents of varying heights as it climbs over the hilly terrain. The tallest bents have one or two struts to provide transverse restraint between the columns. The bridge has both straight and curved spans. For convenience, the bridge structure can be divided into six sections as summarized in Table 1. The superstructure was a prestressed box girder with a drop-in T-girder span between Bent 9 and Bent 10. There were expansion joints at Bents 2, 6, 9, 10, 14, and at the two seat-type abutments. For the drop-in span, the bridge deck just rested on the bent cap at its both ends.

At the curved part of the bridge, the bridge is likely subjected to higher deformation and stress under the earthquake, resulting in collapse. Even on the straight part of the bridge, due to tall columns, the damage in various sections resulted in tilting of the columns that pushed the superstructure almost off their support at several locations. A detour had been graded along the side of the damaged bridge. Considering the high risk of further collapse during an aftershock that could endanger people using the detour, the rest of the bridge was demolished with dynamite as illustrated in Fig. 22.

Similar to the previously described Xiaoyudong Bridge, this bridge could have been damaged by surface faulting though there is no clear surface fault feature observed by the reconnaissance team near the bridge site. Considering the complex vibration system
